## RESIDENTIAL INSPECTION

1234 Main Street  
Peachtree City, GA 30269

06/11/2025 9:00AM

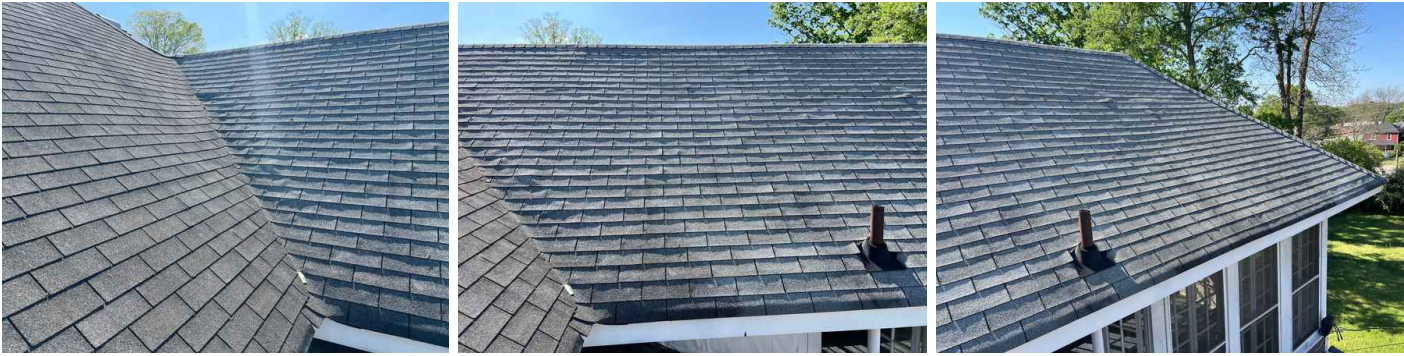
Flashing: Wall Intersections

Checking for flashing where the roof covering meets a wall or siding material is important in preventing water intrusion. Proper step and counter flashing should be installed in these areas to prevent water from seeping through. However, it's important to note that this inspection is not an exhaustive inspection of all flashing areas.

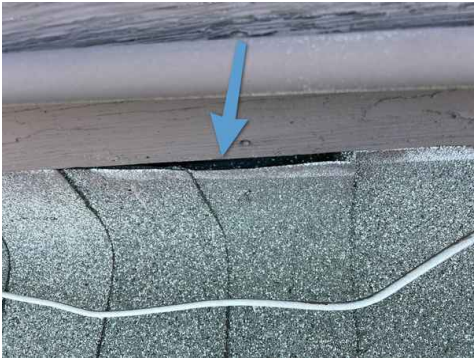
A vulnerable area was observed where the roofing meets the wall, which can allow water intrusion if left unaddressed. I recommend having a qualified roofing professional evaluate the area and perform any necessary corrections, such as installing proper flashing or sealing, to prevent potential moisture-related damage.

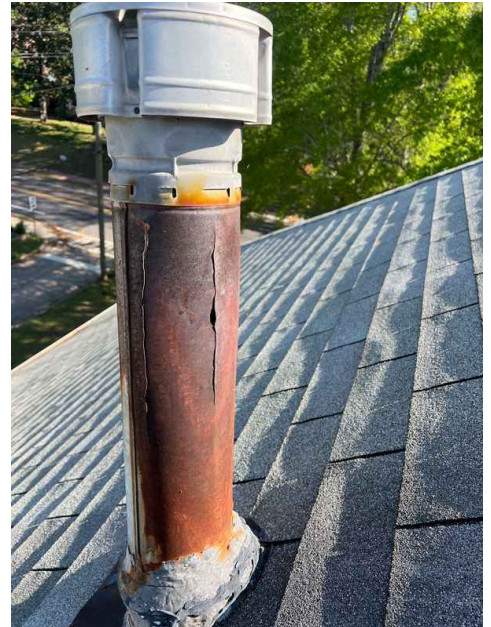
**DEFECT AT PIPE**

A deteriorating vent pipe was observed on the roof. This can be a potential source of water intrusion and may compromise the integrity of the roofing system. I recommend seeking the expertise of a qualified roofing contractor to assess the condition of the vent pipe, determine the extent of deterioration, and perform any necessary repairs or replacements to prevent further damage and ensure proper ventilation.

Contact a qualified professional.

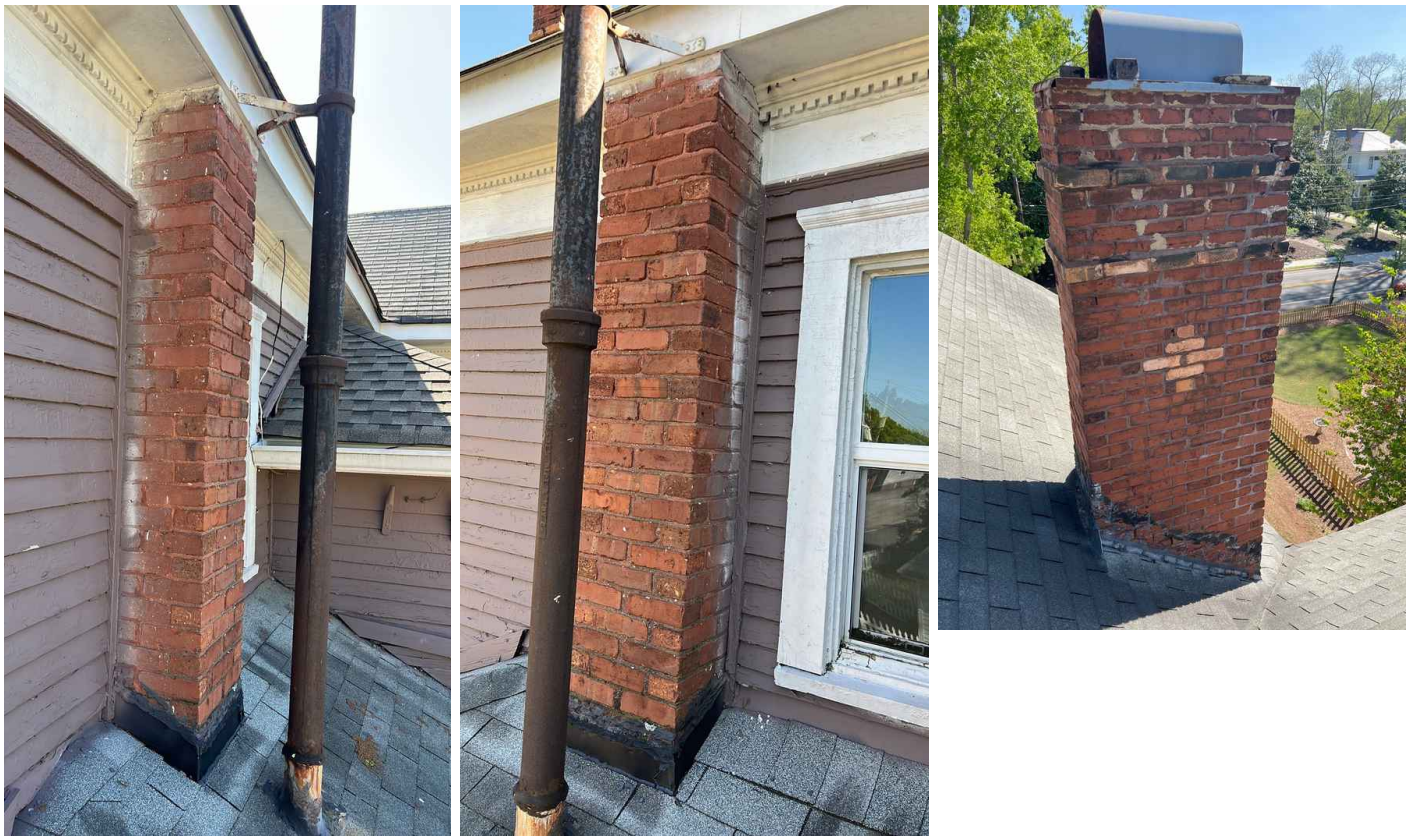
##### Masonry Chimney: Masonry Chimney Exterior Was Inspected

The chimney exterior was inspected during my home inspection.

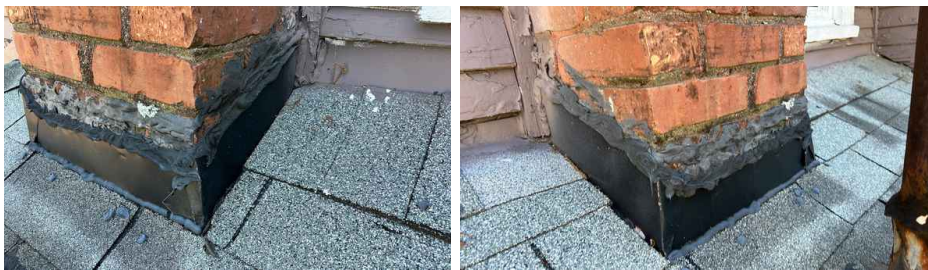
##### Masonry Chimney: Masonry Chimney Flashing Was Inspected

I inspected for flashing installed at the chimney.

Flashing is installed in areas where the chimney stack meets another system or component of the house. And the flashing is supposed to divert water away from those areas to prevent water intrusion.

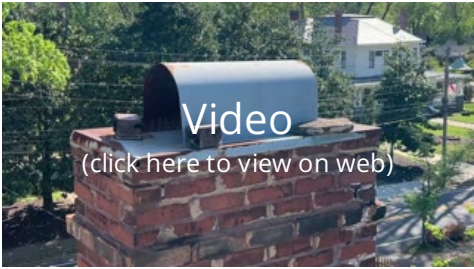
3.1.1 Masonry Chimney  
**CHIMNEY RAIN CAP DEFECT**

Recommendation

Contact a qualified chimney contractor.

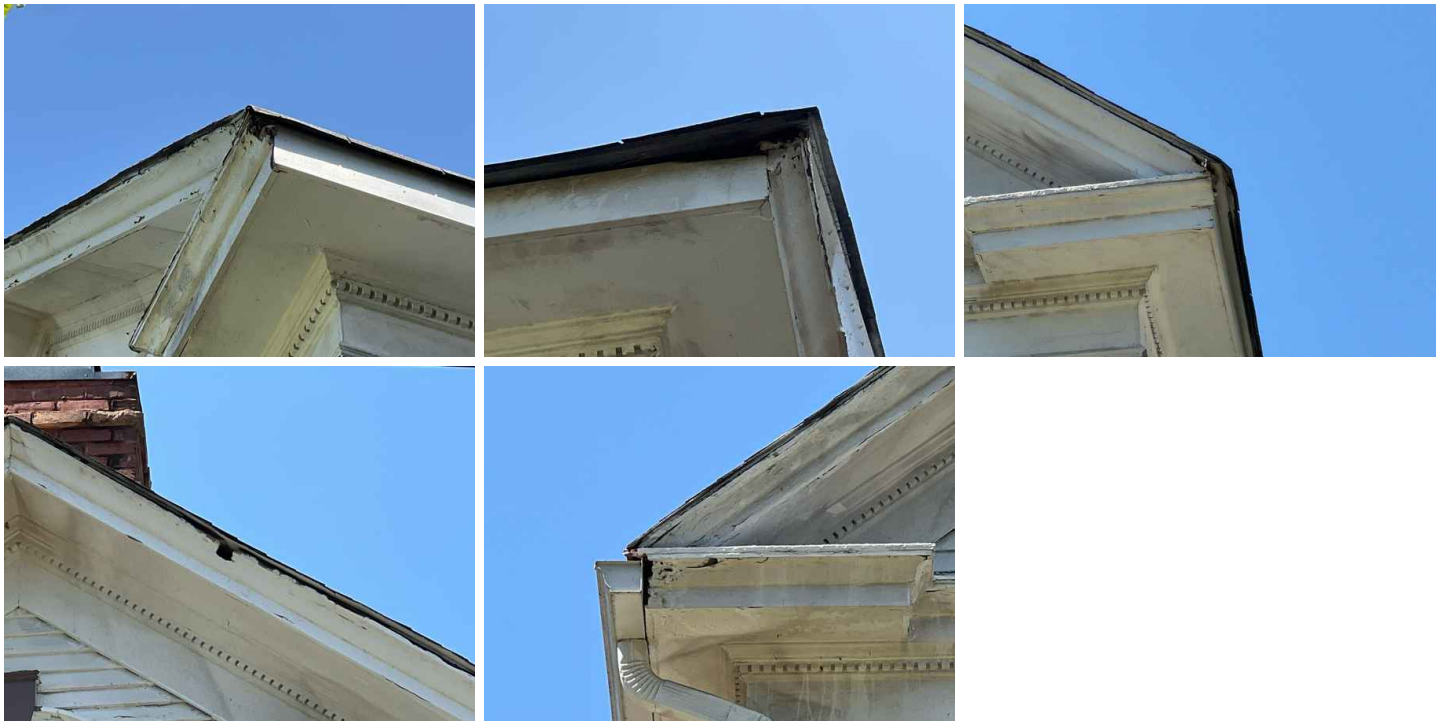
4.2.1 Eaves, Soffits & Fascia

DAMAGE OBSERVED AT FASCIA

Contact a qualified professional.

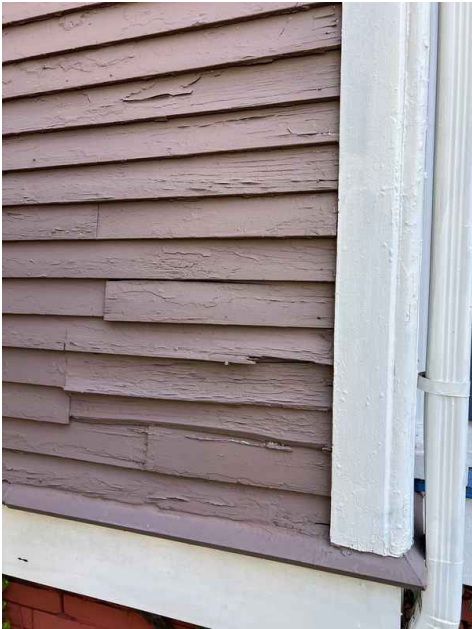
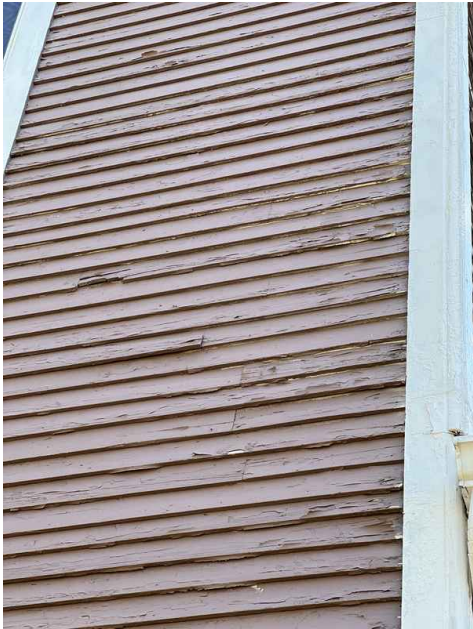
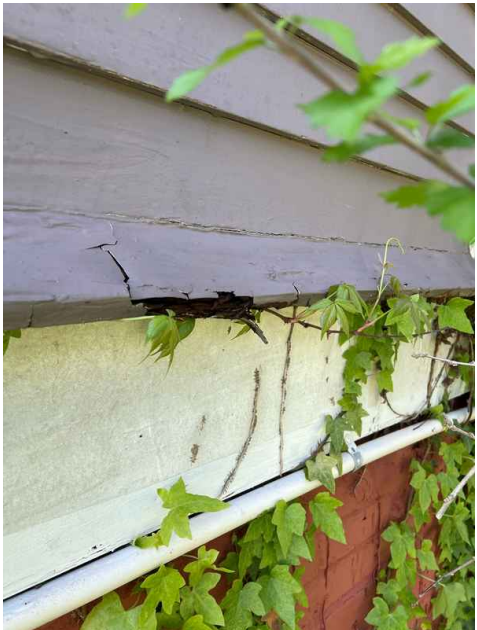
4.3.1 Wall-Covering, Flashing & Trim

**DAMAGED WALL-COVERING MATERIAL**

Contact a qualified professional.

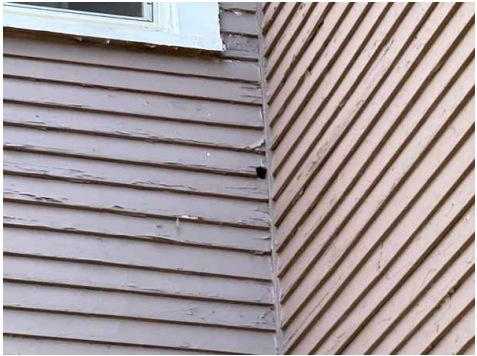
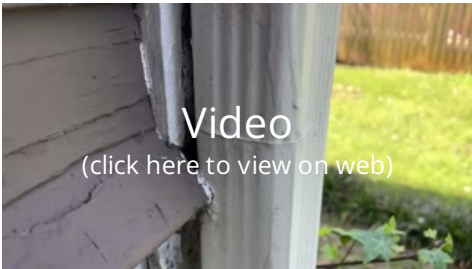
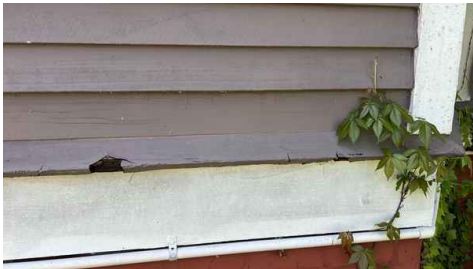
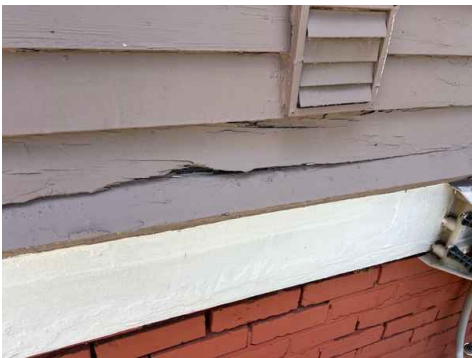
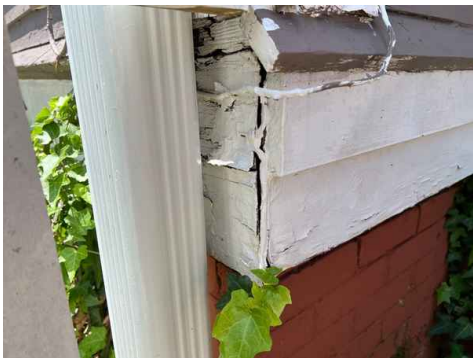
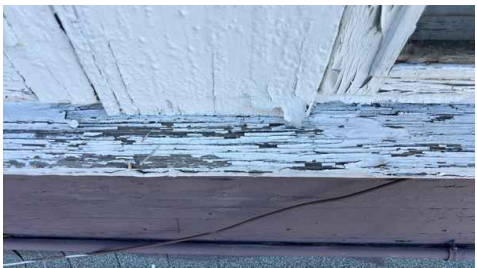
Damage was observed on the wall covering material. It is recommended to address these issues by repairing or replacing the damaged areas. This will help prevent further deterioration and maintain the aesthetic appeal of the walls. Consulting with a professional contractor or handyman can ensure proper repair techniques are employed and restore the wall's integrity.

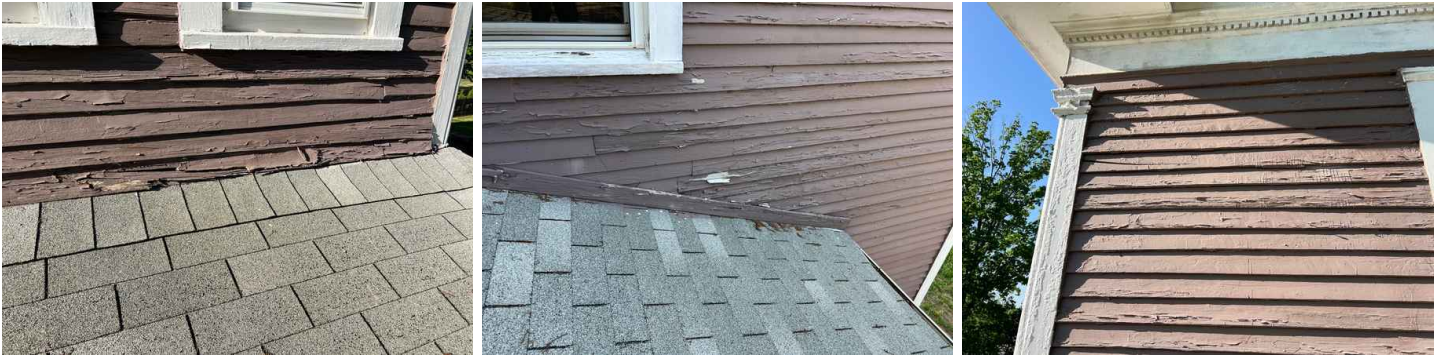
4.3.2 Wall-Covering, Flashing & Trim

**PAINT DETERIORATING**  
THROUGHOUT

Paint deterioration was observed on the exterior of the home, which can expose underlying materials to moisture and environmental damage. I recommend having a qualified professional evaluate the affected areas and perform necessary repainting or touch-ups to protect the structure and maintain the home's appearance.

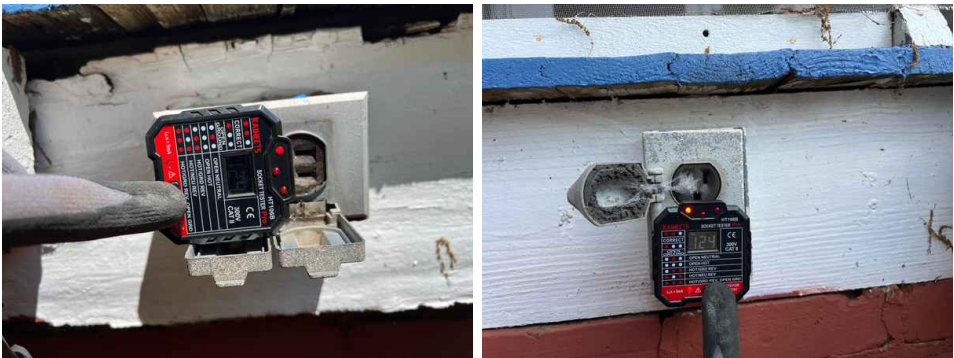
4.4.2 GFCIs & Electrical

**COVER PLATE DEFECT**

A damaged cover plate was observed on an outlet, which may pose a minor electrical safety concern. I recommend replacing the cover plate to ensure proper protection and maintain a safe and finished appearance.

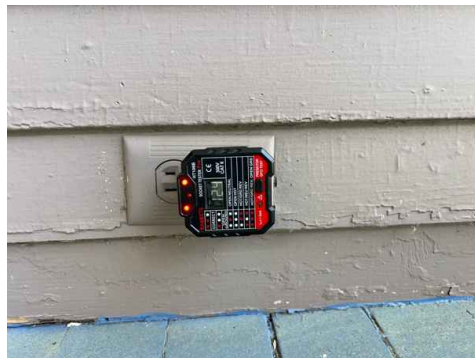
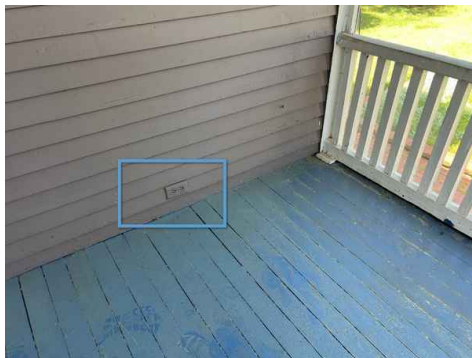
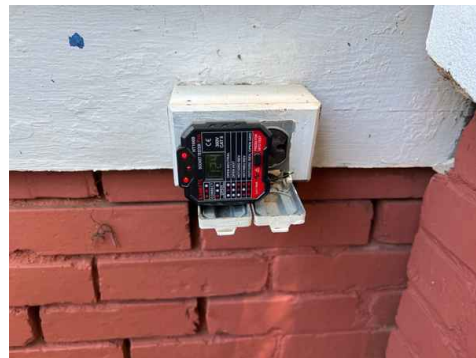
4.4.5 GFCIs & Electrical

**IMPROVE/CORRECT**

The outlets were observed installed incorrectly, which may allow water intrusion and pose a potential electrical hazard. I recommend having a licensed electrician evaluate the installation and make necessary corrections to ensure the outlets are properly sealed and weather-protected.

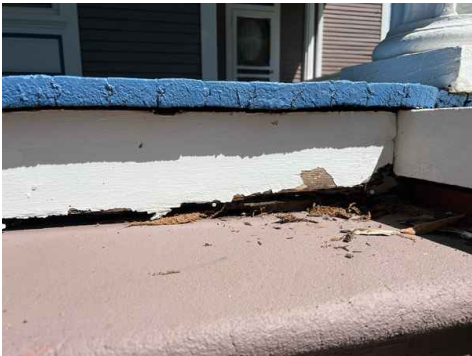
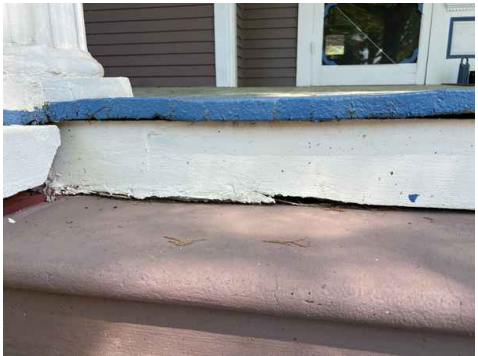
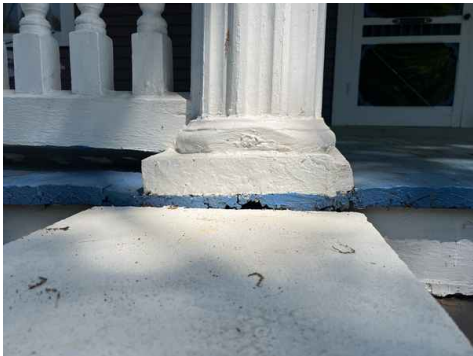
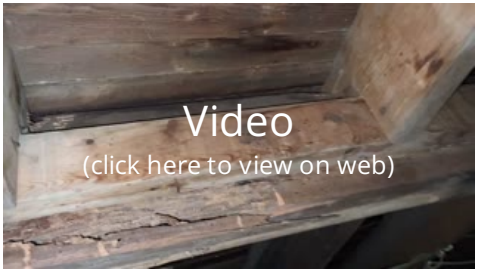
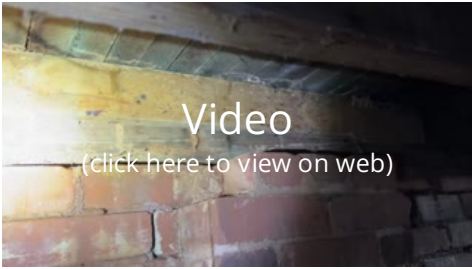
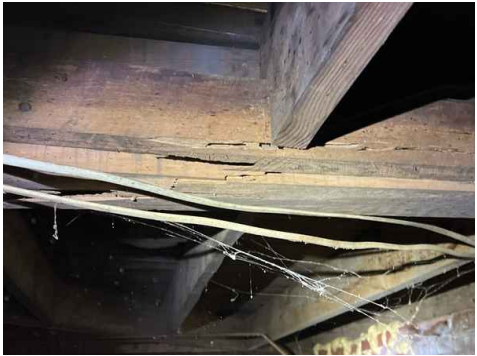
4.5.1 Porches, Patios, Decks, Balconies & Carports

**FURTHER EVALUATION**

Several of the beams observed under the front porch showed signs of extensive pest or rot damage, which may compromise the structural stability of the porch. I recommend having a qualified professional evaluate the affected areas and perform any necessary repairs or replacements to prevent potential structural movement or failure. Prompt action will help maintain safety and prevent further deterioration.

Contact a qualified deck contractor.

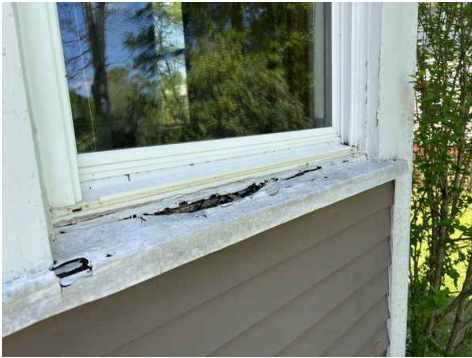
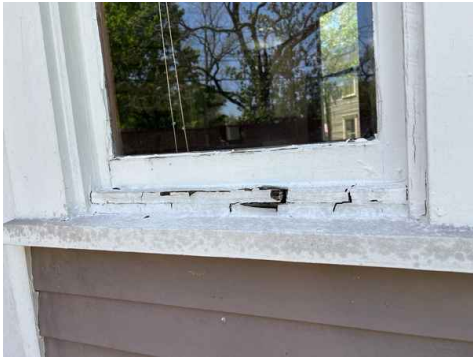
4.6.1 Windows

**WOOD ROT AND DETERIORATION AT WINDOW**

Rot damage was observed at the window, which may lead to further deterioration and potential water intrusion if left unaddressed. I recommend having a qualified professional evaluate the extent of the damage and perform necessary repairs or replacements to restore proper sealing and protect the surrounding materials.

Contact a qualified window repair/installation contractor.

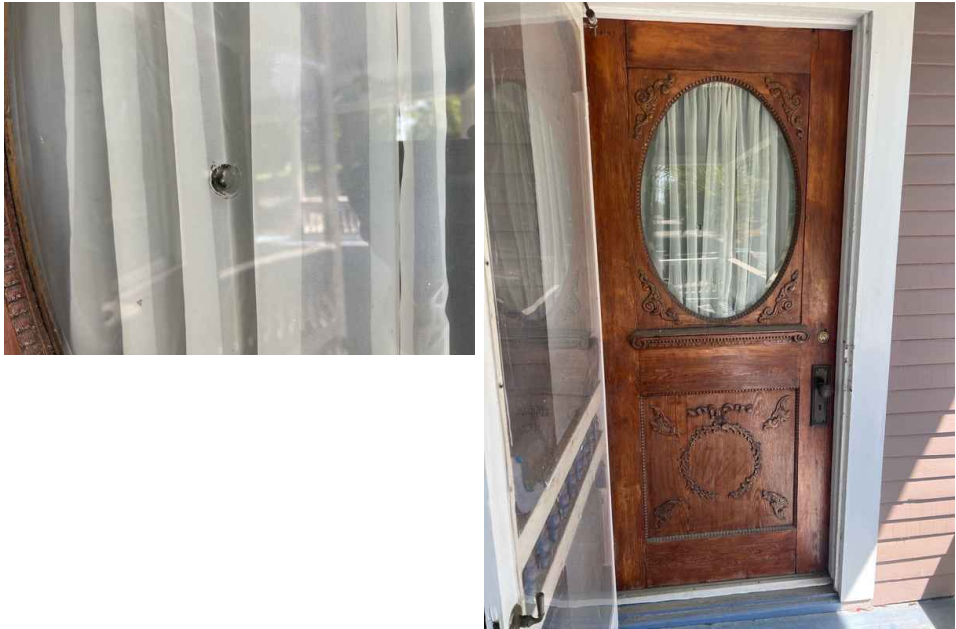
4.7.1 Exterior Doors

**DAMAGED GLASS**

Damaged glass was observed at the door, which may pose a safety risk and reduce energy efficiency. I recommend having a qualified professional evaluate the condition and perform necessary repairs or replacement to restore both safety and functionality.

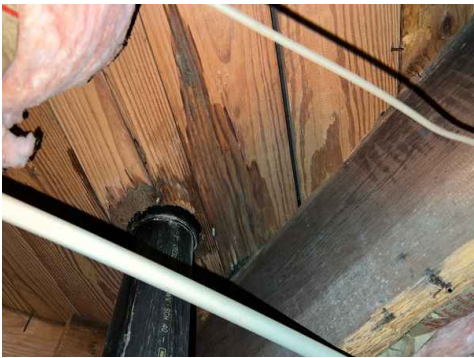
**WATER STAINS**

During the inspection, I observed water stains on the subfloor in the crawlspace. This could be an indication of a past or ongoing water intrusion issue, which may result in structural damage, mold growth, or other related problems. I recommend that a qualified professional further investigate the source and extent of the water damage and take appropriate measures to address the issue to prevent any further damage.

Recommendation  
Contact a qualified professional.

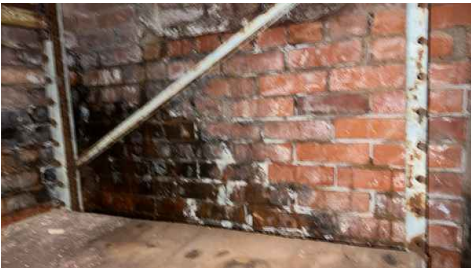
5.1.4 Crawlspace

**MOISTURE IN CRAWLSPACE**

Moisture in the crawlspace could be a potential issue that may lead to mold growth, wood rot, or other structural problems. It is recommended to identify the source of the moisture and make necessary repairs to prevent further damage. This could involve improving drainage around the home, repairing any leaks or cracks in the foundation or walls, or installing a vapor barrier to control moisture levels.

Recommendation  
Contact a qualified professional.

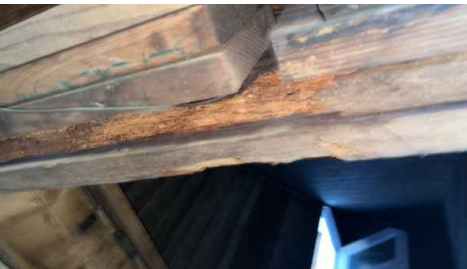
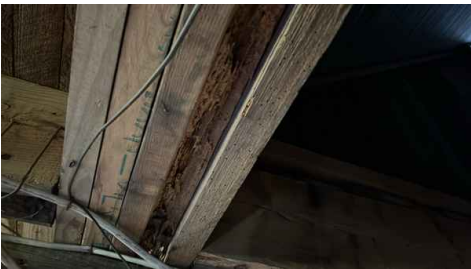
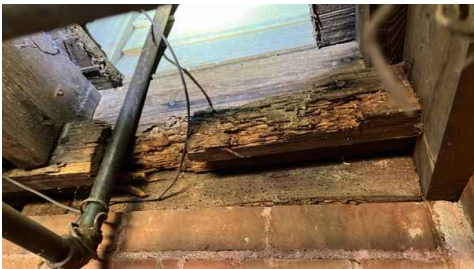
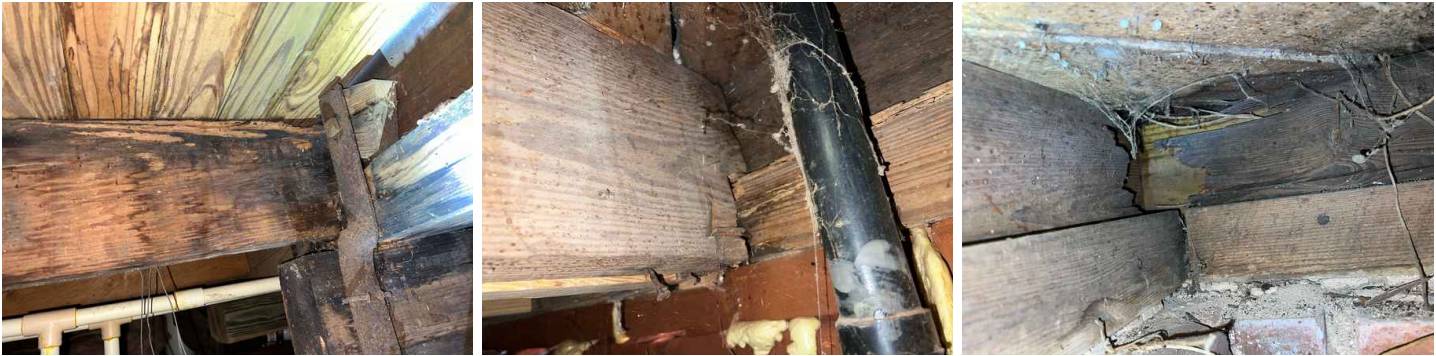
5.1.5 Crawlspace

**PEST CONTROL SPECIALIST**

Pest damage was observed in the crawlspace, which may affect the structural components and overall condition of the home. I recommend having a licensed pest control specialist evaluate the extent of the infestation and perform treatment if necessary. Further assessment by a qualified contractor may also be needed to repair any damage caused.

Recommendation  
Contact a qualified pest control specialist.

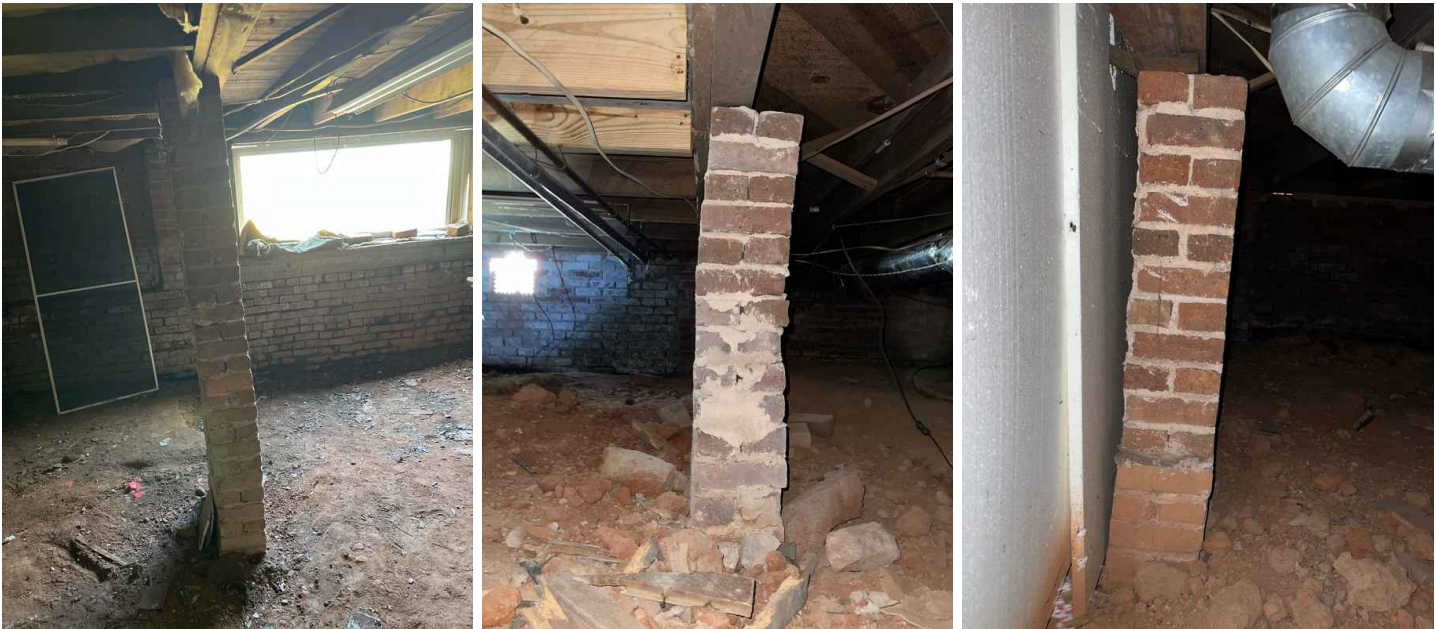
5.1.6 Crawlspace

**PIER LEAN**

Contact a foundation contractor.

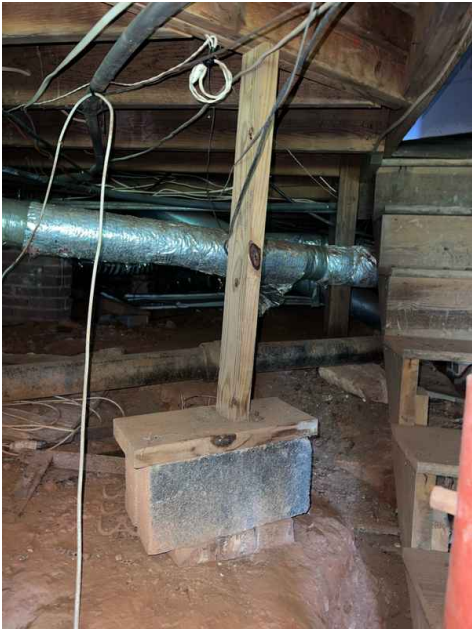
5.1.7 Crawlspace

**INADEQUATE SUPPORT**

Missing Ledger Strip

Contact a foundation contractor.

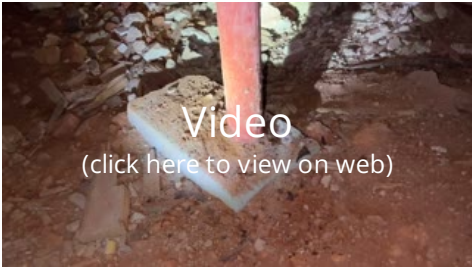
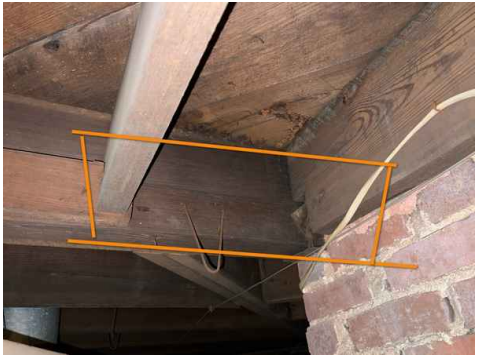
Inadequate supports were observed in the crawlspace, which may compromise the structural stability of the home over time. I recommend having a qualified professional evaluate the current support system and implement the necessary corrections to ensure proper load distribution and long-term structural integrity.

Recommendation

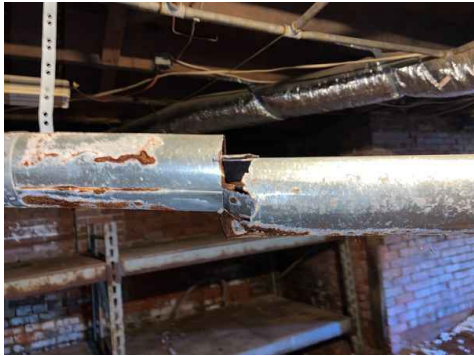
VENT DEFECT

The furnace vent was observed to be disconnected and damaged, which can pose safety risk such as improper venting of combustion gases. I recommend having a licensed HVAC professional evaluate the system and perform the necessary corrections to ensure safe and efficient operation. Prompt action is important to prevent potential health and safety hazards.

Recommendation  
Contact a qualified HVAC professional.

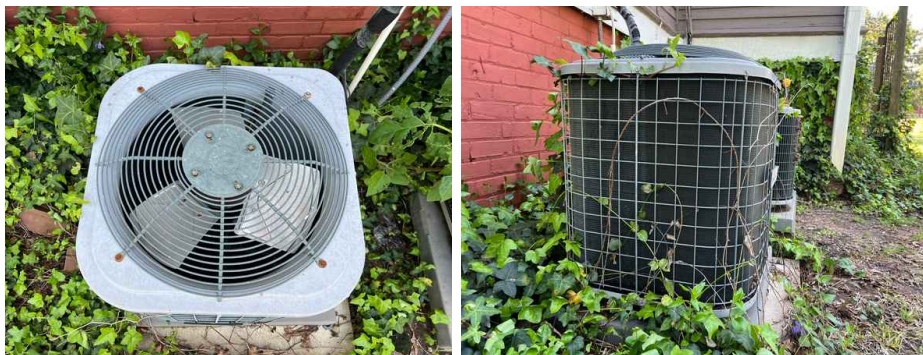
### Cooling System Information: Service Disconnect Inspected

As part of my inspection, I noticed that there was a service disconnect located within sight of the cooling system. This is an important safety feature that allows for the quick and easy shut-off of power to the cooling system in the event of an emergency or during routine maintenance.

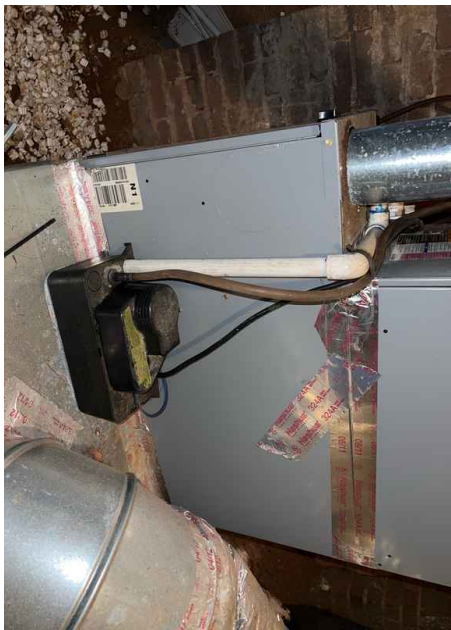
Condensate: Condensate Pump

A condensate pump is an essential component in HVAC systems that efficiently collects and removes the condensate water generated during the cooling process. The pump works by storing the water in a reservoir and then pumping it out through a discharge line to a suitable location.

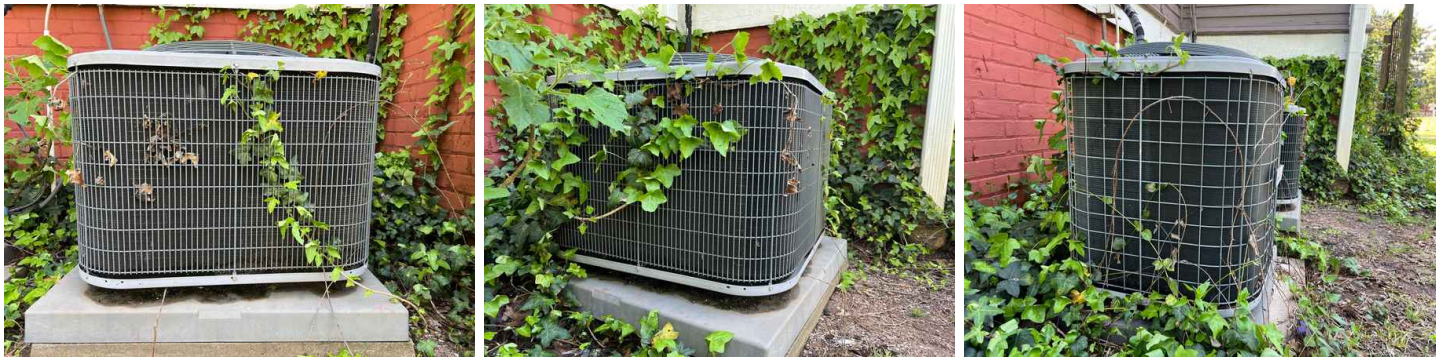
7.1.1 Cooling System Information

I observed dense vegetation around the exterior cooling unit. Vegetation was too close to the unit, which can limit heat dissipation and limit effectiveness. Recommend cutting back vegetation to help improve performance.

Contact a handyman or DIY project

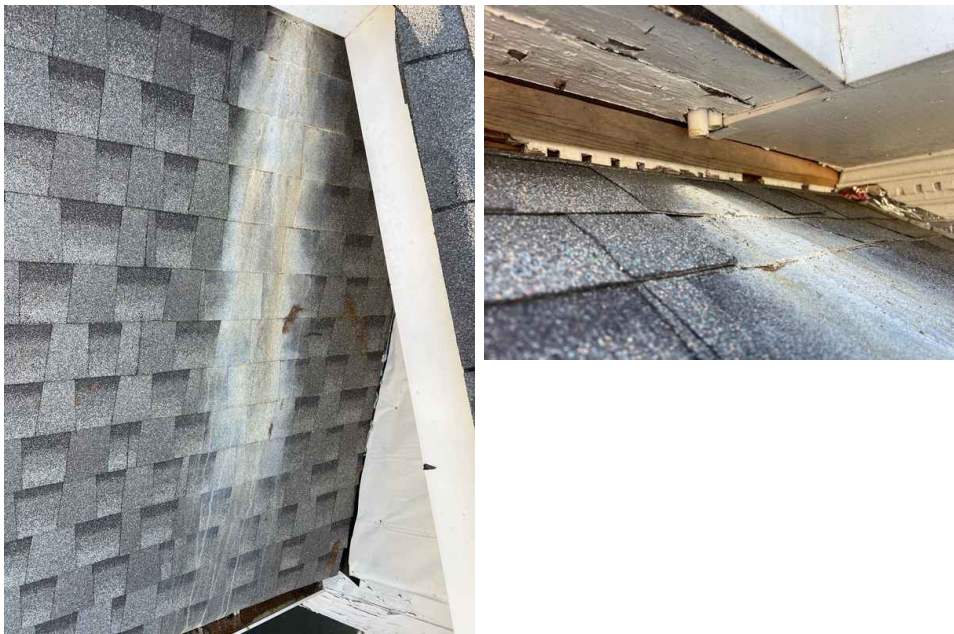
7.2.1 Condensate

**CONDENSATE DISCHARGE SHOULD BE EXTENDED**

Contact a handyman or DIY project

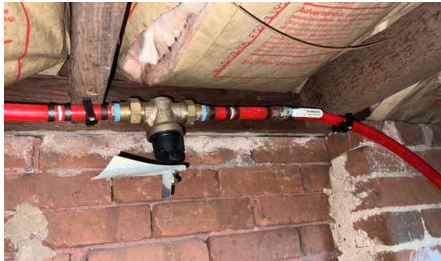
##### Location of Main Shut-Off Valve

Crawlspace

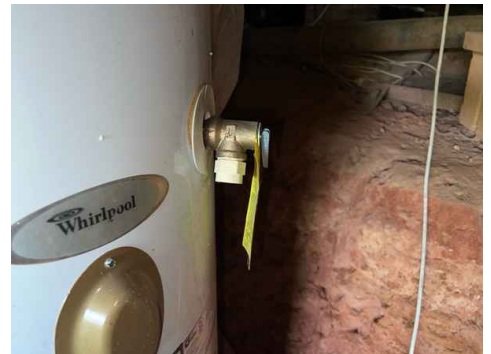
#### **DEFECT AT TPR VALVE DISCHARGE**

I observed a defect at the TPR (temperature, pressure, and relief) valve. The discharge pipe that serves a temperature pressure relief valve should discharge to a safe exterior or drain location.

Contact a qualified plumbing contractor.

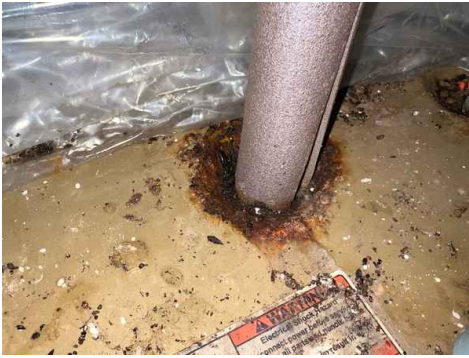
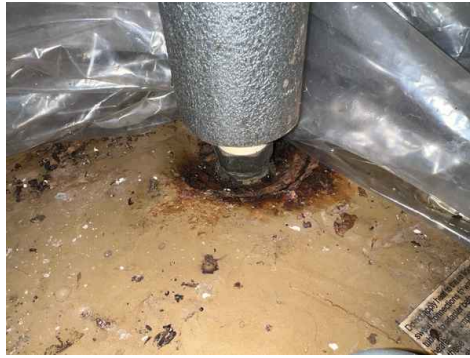
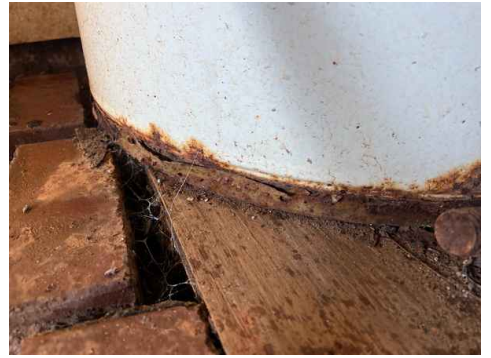
### 8.3.2 Hot Water Source

#### **CORROSION**

During the inspection, corrosion was observed at the hot water source. Corrosion can indicate a potential issue with the plumbing system or the hot water heater itself. It is recommended to have a professional plumber evaluate the situation to determine the cause of the corrosion and to make any necessary repairs or replacements.

Contact a qualified plumbing contractor.

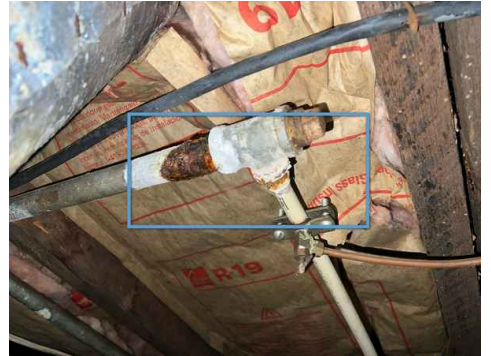
## 8.5.1 Water Supply &amp; Distribution Systems

**CORROSION**

Corrosion was observed on piping in the crawlspace, which may indicate aging or deteriorating materials that could eventually lead to leaks or failures. I recommend having a licensed plumber evaluate the affected piping and perform any necessary repairs or replacements to ensure the integrity of the plumbing system and prevent potential water damage.

Contact a qualified plumbing contractor.

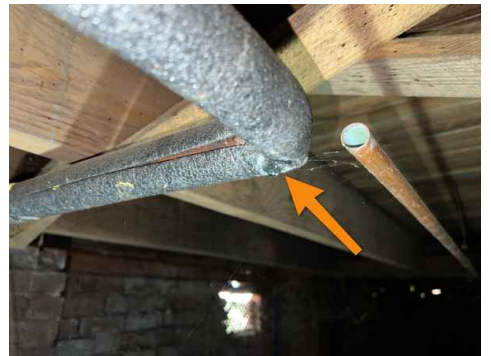
## 8.5.2 Water Supply &amp; Distribution Systems

**LEAK**

A leak was observed at a supply pipe in the crawlspace, which may lead to moisture-related damage or reduced water efficiency if not addressed. I recommend having a licensed plumber evaluate the leak and perform the necessary repairs to restore proper function and prevent further issues. Prompt correction will help protect the home's structure and plumbing system.

Contact a qualified plumbing contractor.

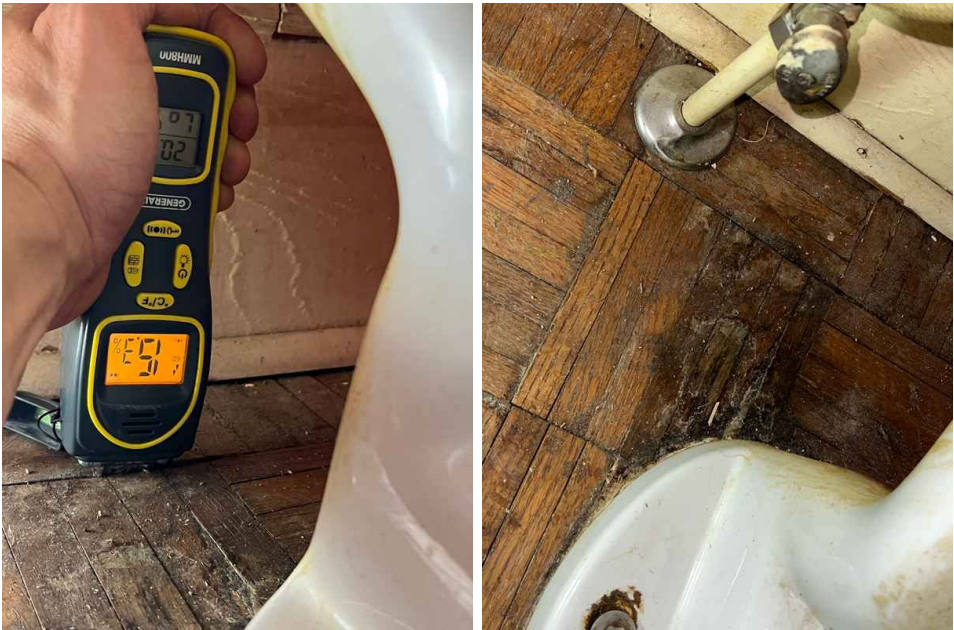
9.1.1 Bathroom Toilets  
**STAIN AROUND BASE**  
1ST FLOOR BATHROOM

A stain was observed at the base of the toilet, which may indicate a potential leak or an issue with the toilet seal or connection that needs to be addressed. I recommend having a qualified professional evaluate the area to determine the cause and perform any necessary repairs. Prompt correction can help prevent water damage and ensure the toilet functions properly.

Recommendation  
Contact a qualified plumbing contractor.

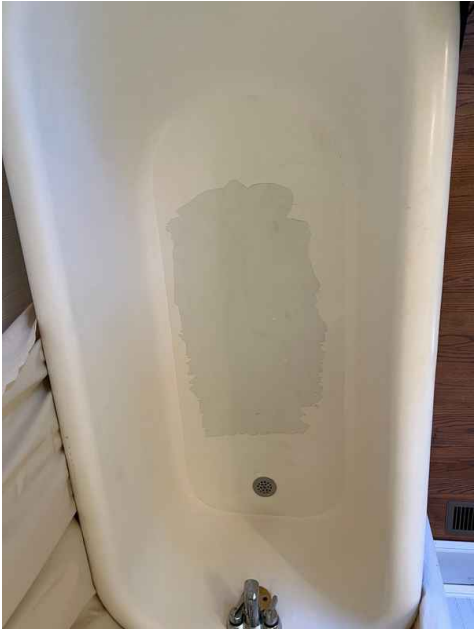
9.2.1 Sinks, Tubs & Showers

A slow-draining tub can indicate a clog or other issue in the plumbing system. It is recommended to evaluate the drain to identify the cause and correct it to restore full drainage function. Potential solutions include using a plunger, a drain snake, or chemical drain cleaners. If these methods do not resolve the issue, a professional plumber may be needed to inspect and fix the problem.

Recommendation  
Contact a qualified plumbing contractor.

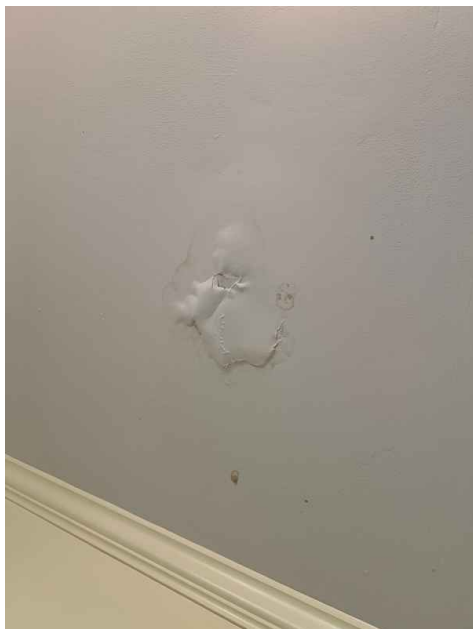
9.3.2 Cabinetry, Ceiling, Walls & Floor

**STAIN**

The presence of a water stain on the bathroom ceiling is an indication of a potential water leak or moisture issue. It is recommended to have a professional evaluate and make repairs as necessary. The seller should also disclose any known issues related to the water stain to ensure transparency.

Recommendation  
Contact a qualified professional.

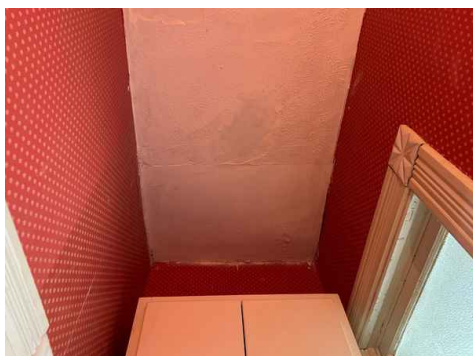
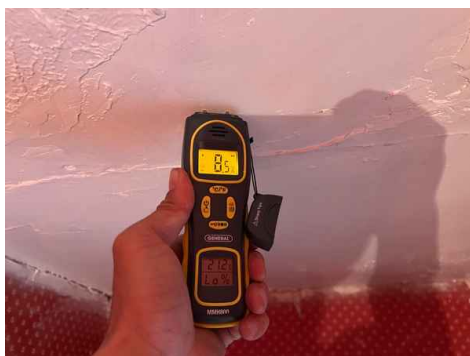
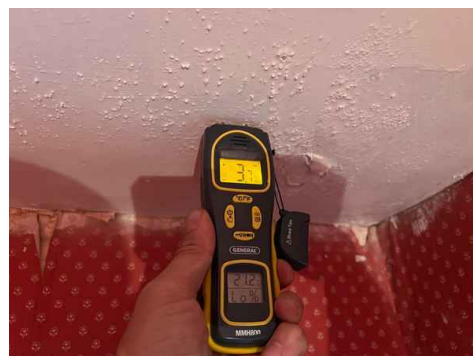
### 9.3.3 Cabinetry, Ceiling, Walls & Floor

#### **REPAIR NOTED**

During the home inspection, a patched area was observed on the ceiling. It's recommended to ask the owners about the nature of this repair to understand any past issues or maintenance work.

Contact a qualified professional.

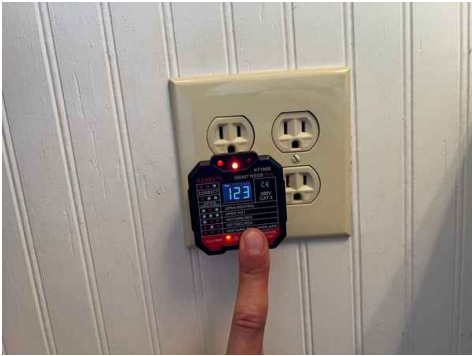
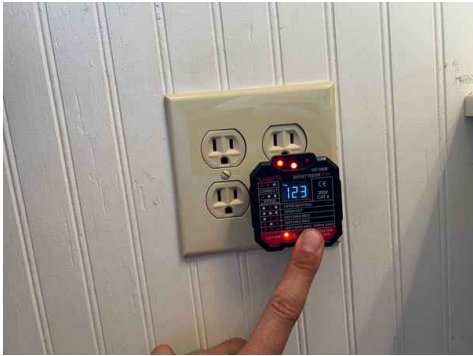
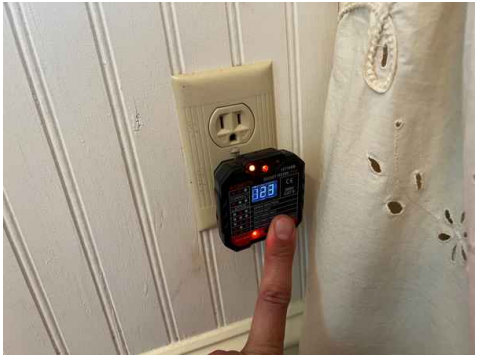
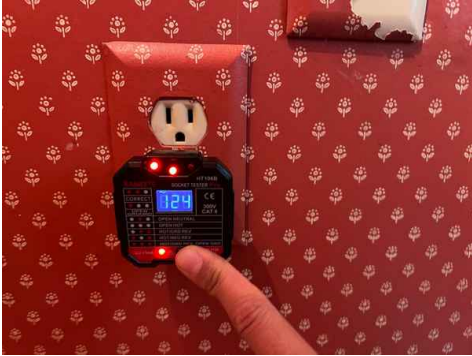
### 9.5.1 GFCI & Electric in Bathroom

#### **RECEPTACLE IS NOT GFCI PROTECTED**

During the inspection, I have detected that the receptacle in the bathroom is not functioning as a GFCI (Ground Fault Circuit Interrupter) protected outlet. This is a safety concern that requires prompt attention to avoid potential electrical hazards, especially in areas exposed to water.

Contact a qualified electrician

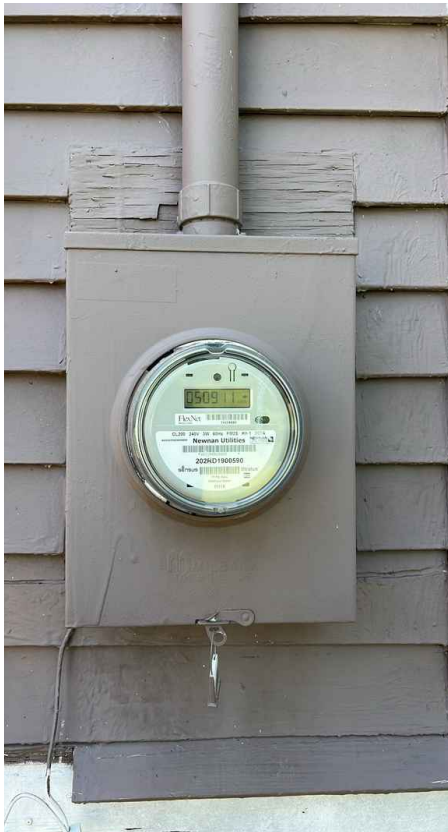
### Electric Meter & Base: Inspected the Electric Meter & Base

During the home inspection, I thoroughly inspected the electrical meter and base. This included checking for proper installation and ensuring that the components were functioning properly. Any deficiencies or safety hazards identified during the inspection would be noted in the report, and recommendations would be made for further inspection or repair by a licensed electrician if necessary. It's important to ensure that the electrical meter and base are in good condition to prevent any potential safety hazards or electrical issues in the future.

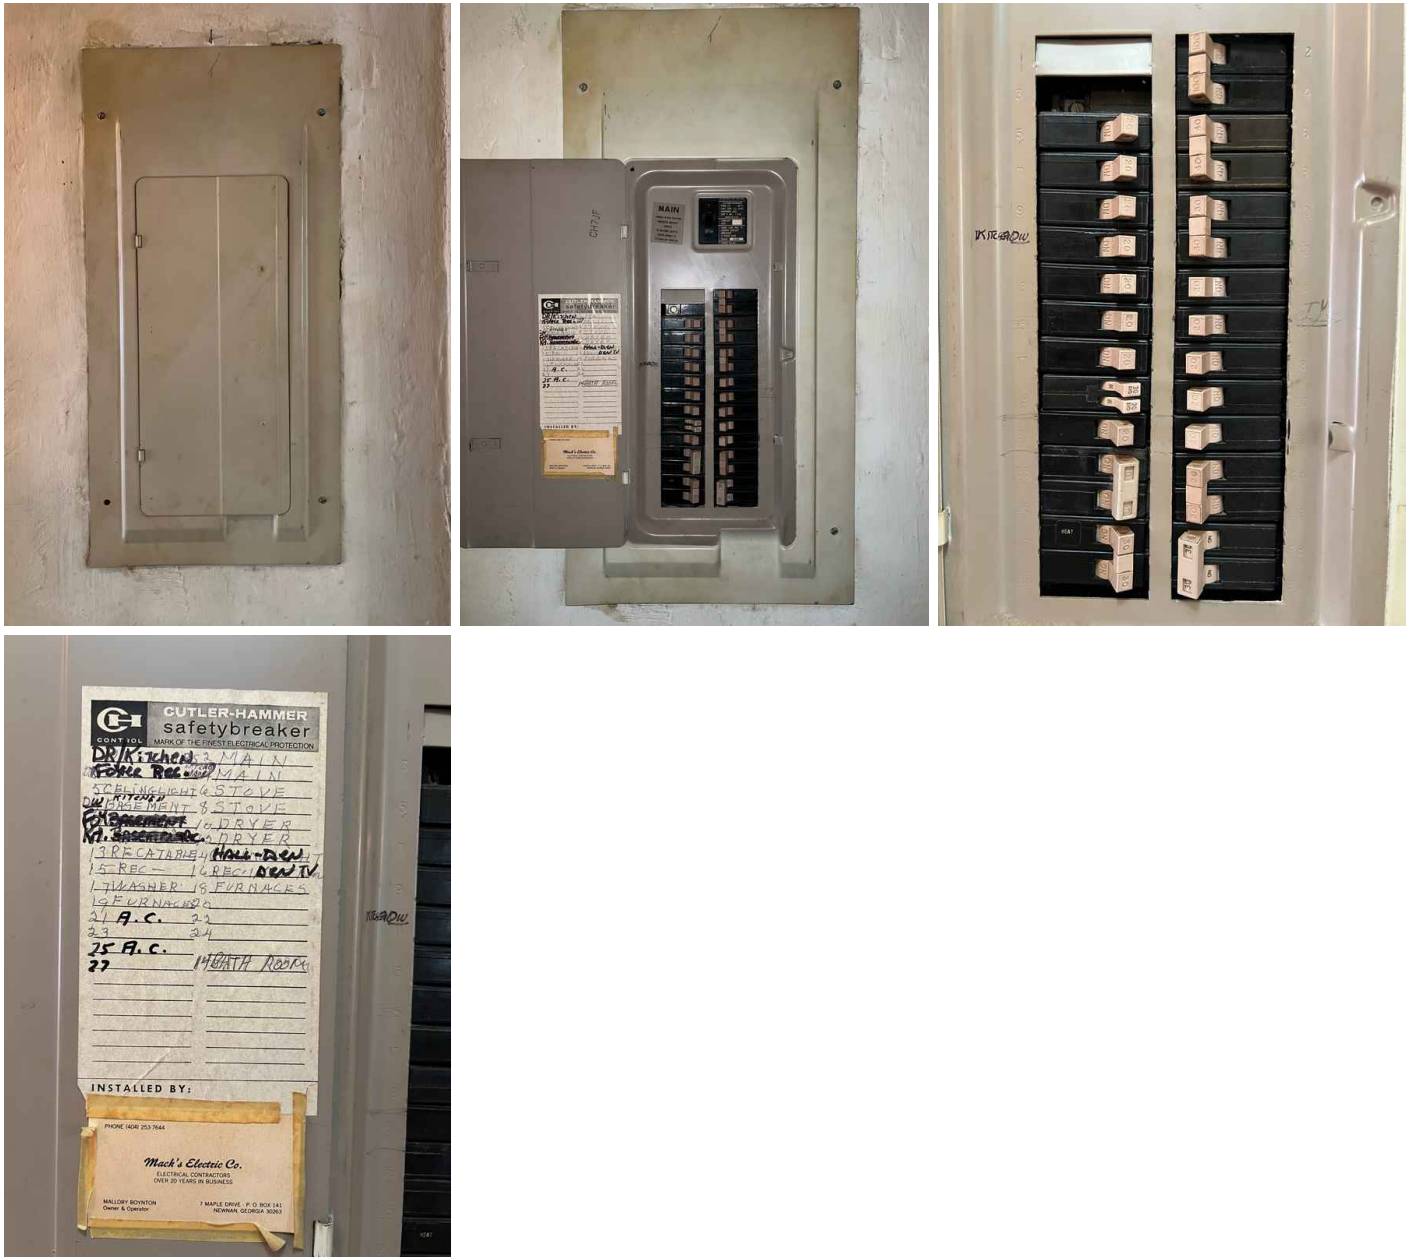
Panelboards & Breakers: Inspected Main Panelboard & Breakers

During the inspection, I conducted a comprehensive examination of the electrical panelboards and over-current protection devices, such as circuit breakers and fuses. This inspection allowed me to identify any potential issues with the electrical system, such as overloaded circuits or damaged breakers, that could impact the safety or functionality of the home. Additionally, I checked for proper labeling and clear access to the panelboards to ensure they are easily accessible and safe for maintenance.

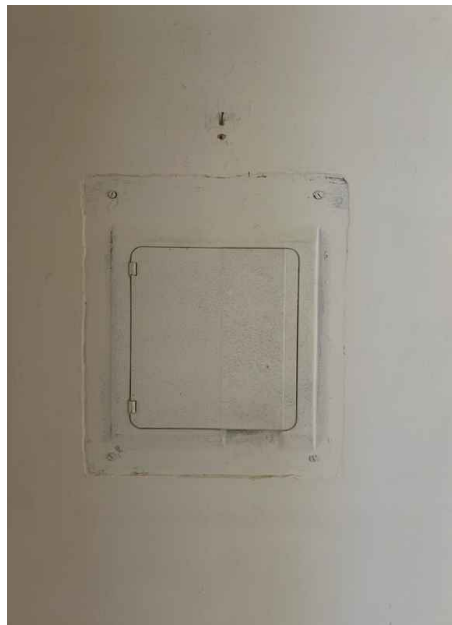
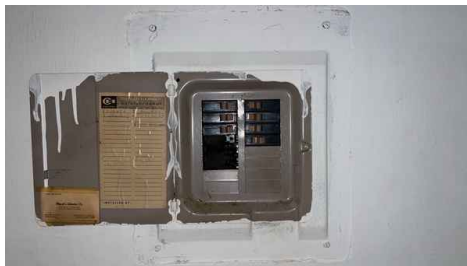
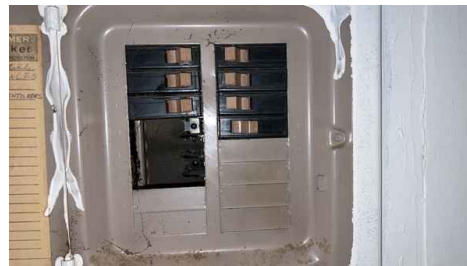
## Panelboards & Breakers: Inspected Subpanel & Breakers

I inspected the electrical subpanel and over-current protection devices (circuit breakers and fuses).
