## RESIDENTIAL INSPECTION

1234 Main Street  
Peachtree City, GA 30269

06/11/2025 9:00AM

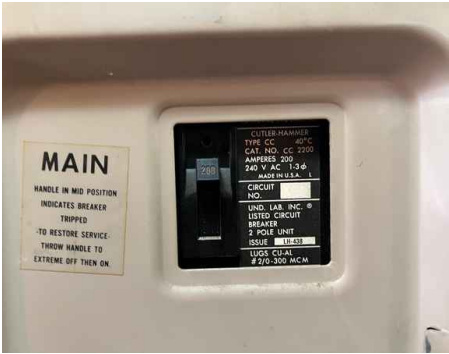
The service panel is the central distribution point that connects the service wire or service drop (the main wire coming from the outside into the house) to the exit wires that split off and service different parts of the house. These exit wires are called branch circuits or branch wire circuits.

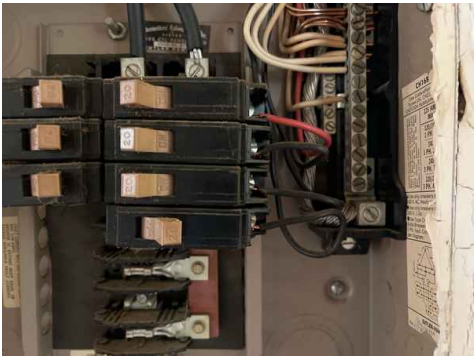
BREAKER(S) IN OFF POSITION

I observed a breaker in the "off" position prior to inspecting the electrical panel. Recommend asking the homeowner what this breaker is connected to, and why it is off.

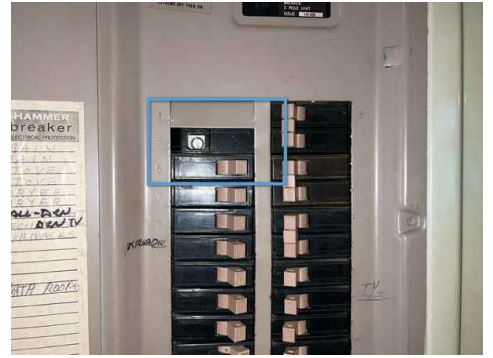
OPEN BREAKER KNOCKOUT (FILLER PLATE MISSING)

The observation of an unused circuit-breaker panel opening without a filler plate is a safety concern as it poses a hazard. If someone were to inadvertently insert their finger or an object into the opening and make contact with live electrical components, it could have severe consequences. It is highly recommended to install a proper filler plate at the electrical panel cover to eliminate this safety risk. This should be done by a licensed electrician to ensure it is done correctly and in compliance with electrical safety standards.

Contact a qualified electrician

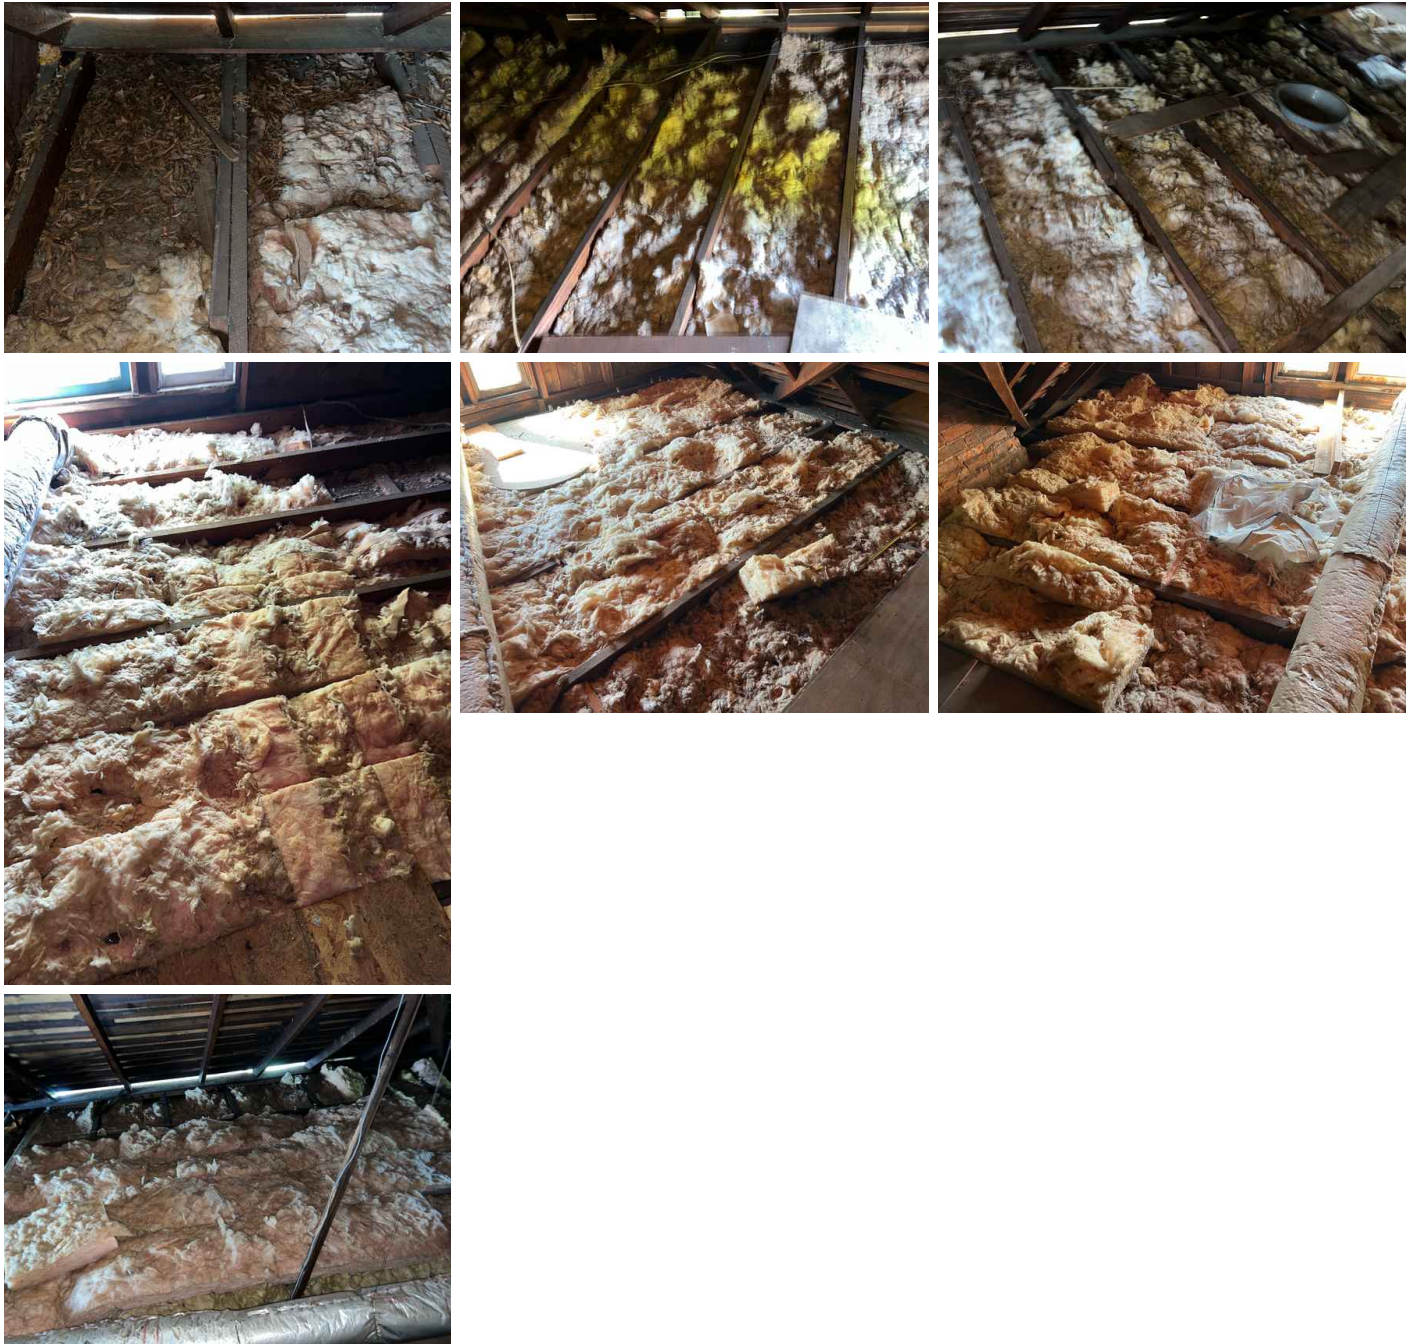
## Insulation in Attic: Insulation Was Inspected

During the home inspection, I inspected for insulation in unfinished spaces, including attics, crawlspaces and foundation areas. I inspected for ventilation of unfinished spaces, including attics, crawlspaces and foundation areas. And I inspected mechanical exhaust systems in the kitchen, bathrooms and laundry area.

I attempted to describe the type of insulation observed and the approximate average depth of insulation observed at the unfinished attic floor area or roof structure.

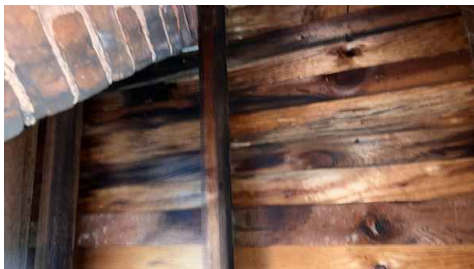
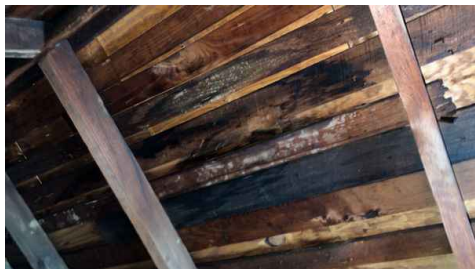
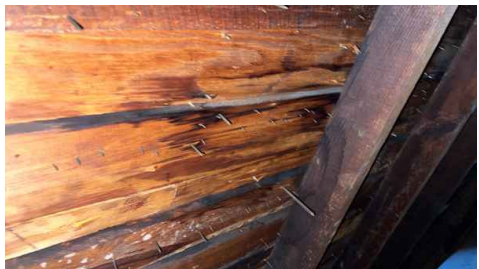
WATER PENETRATION OBSERVED

I observed water marks in the attic, indicating that water penetration or intrusion may have occurred. Water intrusion can cause damage to the home's structural components, insulation, and electrical systems, as well as contribute to the growth of mold and mildew. I recommend having a licensed roofing contractor evaluate the source of the water intrusion and recommend any necessary repairs or maintenance..

Contact a qualified roofing professional.

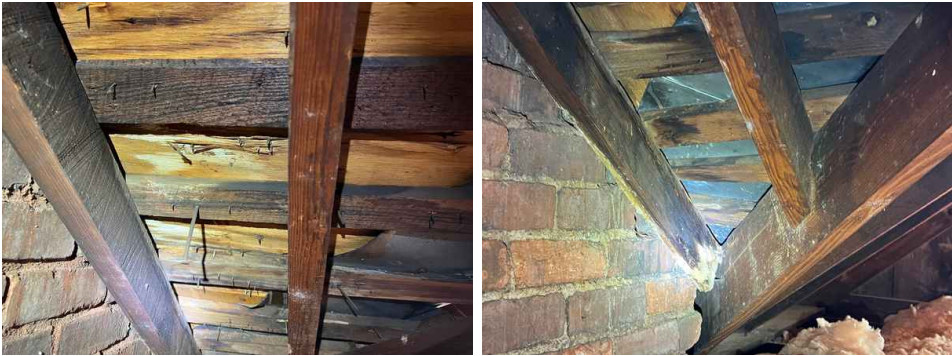
**STRUCTURAL DEFECT IN ATTIC**

During the inspection, a structural defect was observed in the attic where the rafter showed signs of damage or deterioration. It is recommended to consult a professional roofing contractor to further evaluate the condition and extent of the damage. Prompt repairs or replacements should be undertaken to ensure the structural integrity of the roof and prevent any further deterioration or potential hazards.

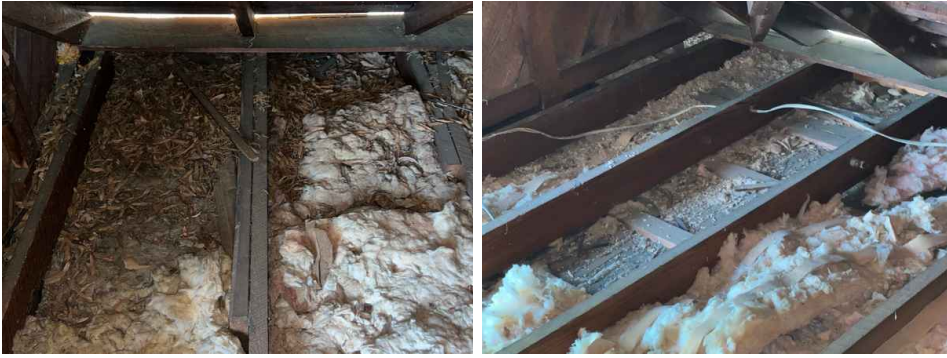
**ADDITIONAL INSULATION RECOMMENDED**

I identified areas lacking sufficient insulation, which could impact energy efficiency and comfort. I recommend a professional air seal these spots and add insulation as needed to enhance thermal performance and reduce energy loss.

Contact a qualified insulation contractor.

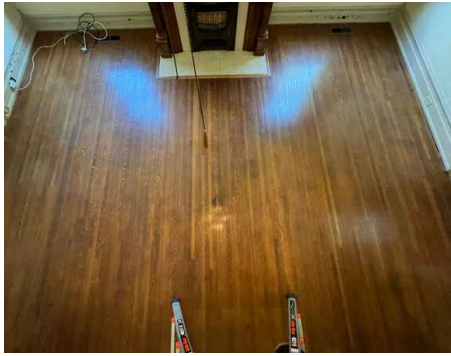
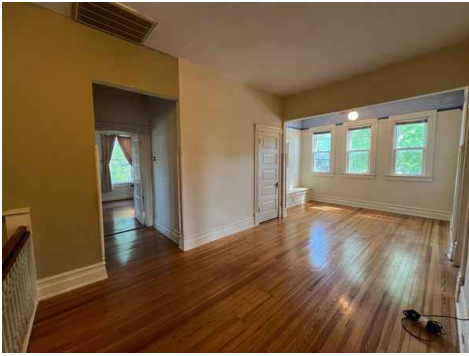
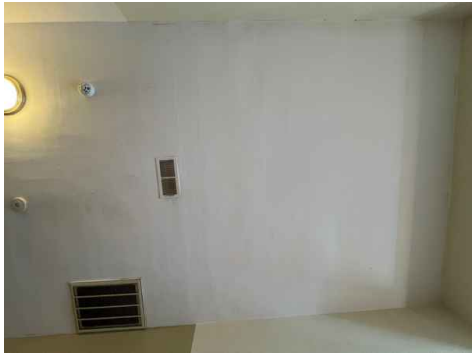
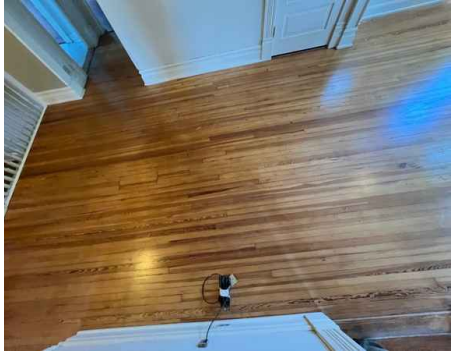
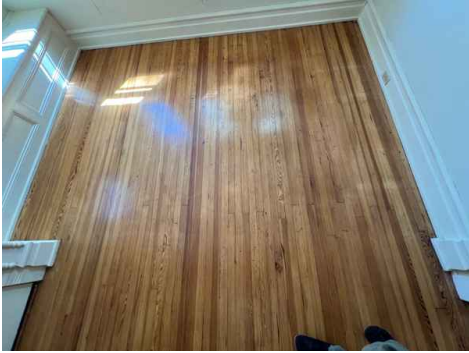
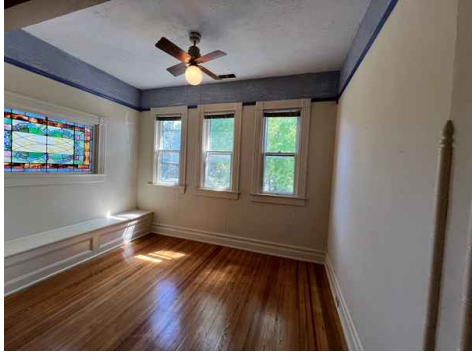
During the inspection, I visually examined the readily visible surfaces of the floors, walls, and ceilings in the home. This inspection allowed me to identify any material defects, such as cracks, water damage, or other issues that could impact the structural integrity or safety of the home. As part of this inspection, I followed the [Home Inspection Standards of Practice](#), and examined these surfaces for any potential issues that may need to be addressed by the homeowner or a professional contractor. It is important to thoroughly inspect the floors, walls, and ceilings in a home to ensure that they are functioning properly and safely, and to identify any issues that may need to be addressed to maintain the home's structural integrity and safety.

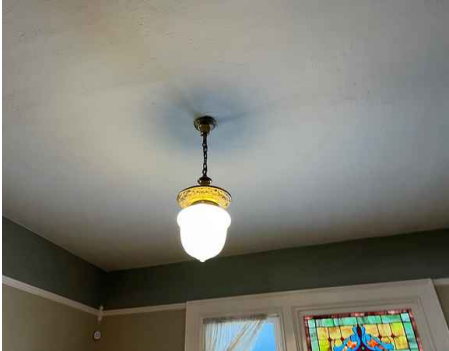
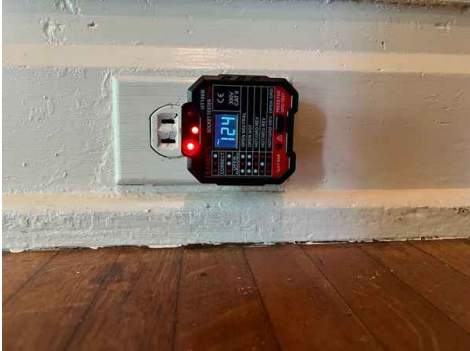
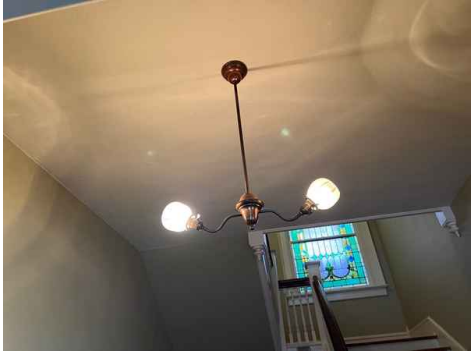
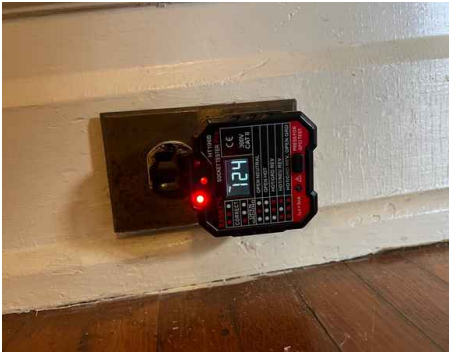
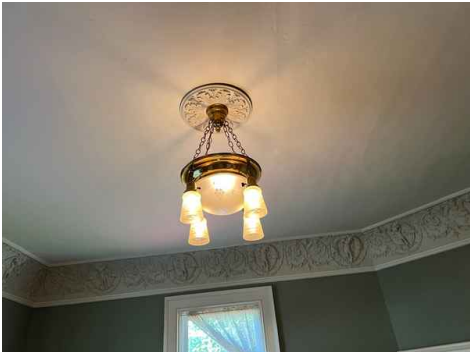
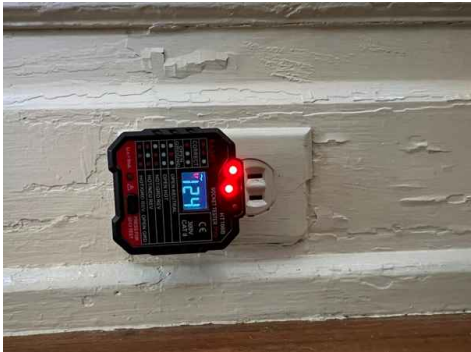
Switches, Fixtures & Receptacles: Inspected a Switches, Fixtures & Receptacles

As part of the inspection, I made sure to evaluate a representative number of switches, lighting fixtures, and receptacles in the home. This inspection allowed me to evaluate the overall condition of the electrical system and identify any potential issues, such as improper wiring, lack of proper grounding, or inadequate circuit protection. By examining these components, I was able to ensure that the electrical system was functioning properly and to identify any potential safety hazards that may need to be addressed. It is important to inspect the switches, lighting fixtures, and receptacles in a home to ensure that the electrical system is safe and reliable, and to identify any issues that may need to be addressed.

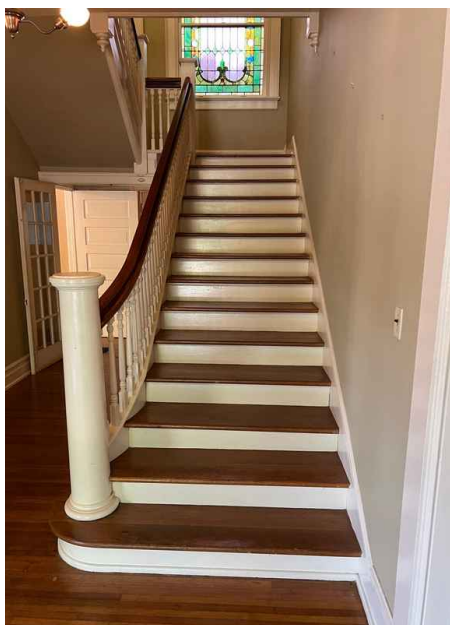
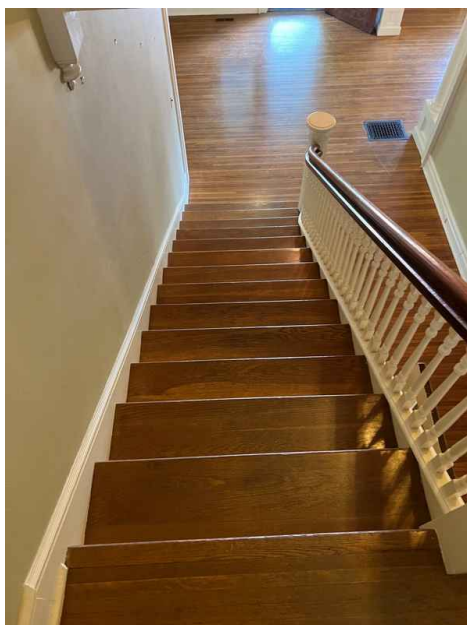
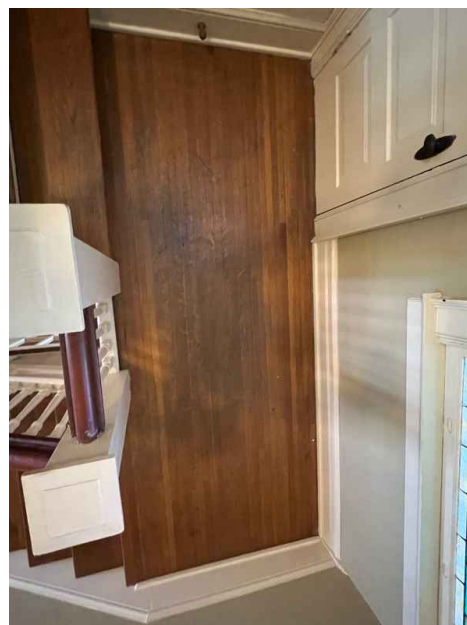
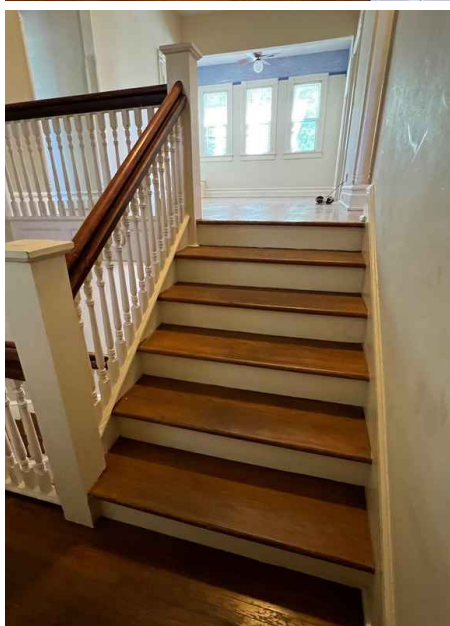
### **Stairs, Steps, Stoops, Stairways & Ramps: Stairs, Steps, Stoops, Stairways & Ramps Were Inspected**

I evaluated the stairs, steps, stoops, stairways, and ramps within the scope of my inspection. These structures play an important role in the safety and stability of the property, so it is crucial to assess their condition and safety.

All treads should be level and secure, and riser heights and tread depths should be as uniform as possible. To meet industry safety standards, stairs should have a maximum riser height of 7-3/4 inches and a minimum tread depth of 10 inches. These guidelines can help ensure that these structures are safe and stable for use.

If you have any concerns or questions about the condition of these structures, I recommend consulting with a qualified contractor who can provide further guidance and recommendations.

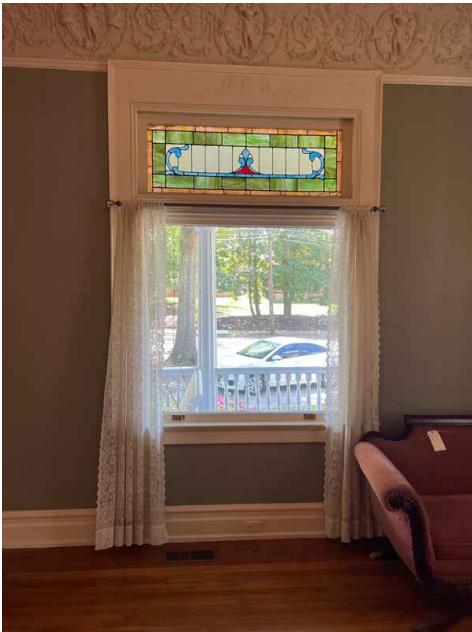
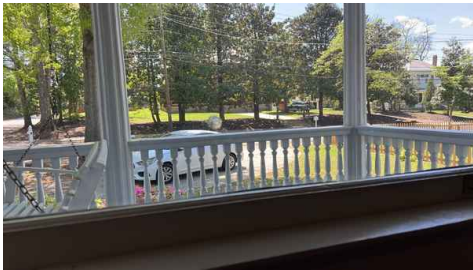
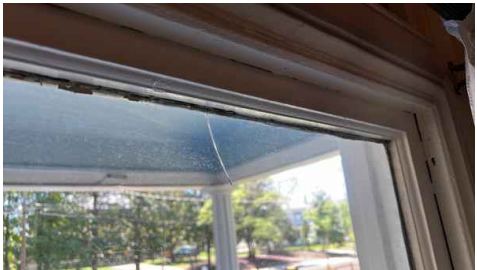
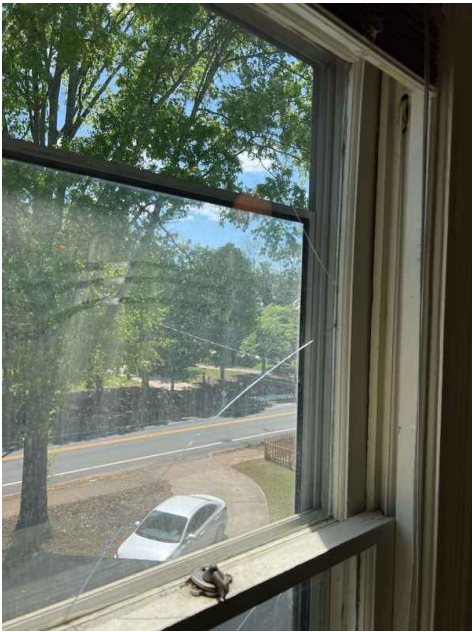
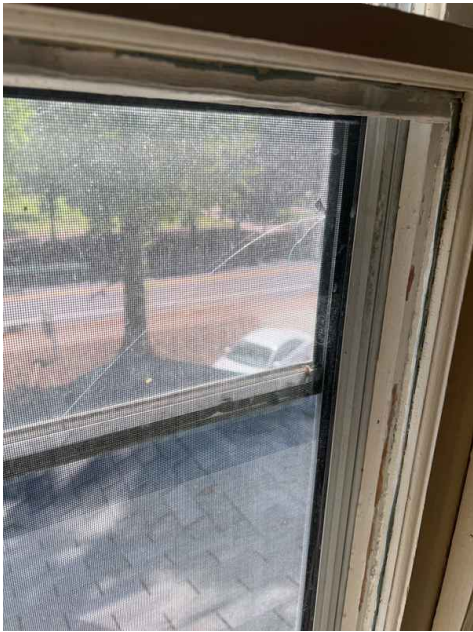
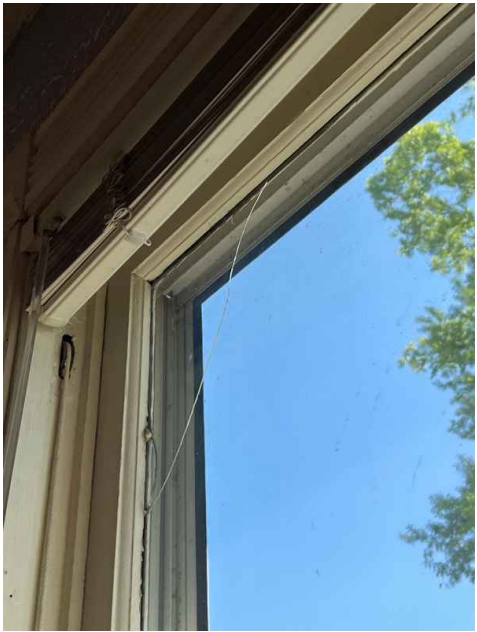
CRACKED GLASS

During the inspection, I observed cracked windowpane glass, which can be hazardous due to the potential for the glass to break further and potentially injure someone or allow air and water to enter the building. It's important to address this issue to ensure the safety and functionality of the window. I recommend further evaluation and replacement of the cracked windowpane glass by a qualified contractor or window specialist.

Contact a qualified window repair/installation contractor.

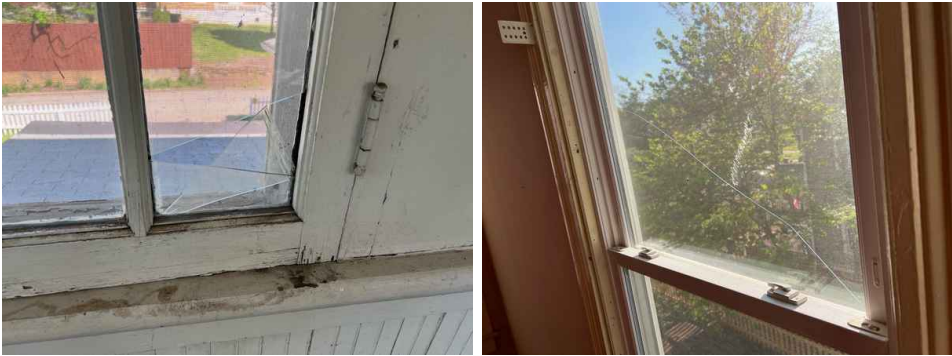
12.2.2 Windows

FOGGED / BROKEN SEAL

Fogged window was observed. This could be an indication of a failure of the window's insulation and can impact its energy efficiency and visual clarity. It is recommended to have a qualified window specialist or contractor evaluate the windows and determine the necessary repairs or replacements.

Contact a qualified window repair/installation contractor.

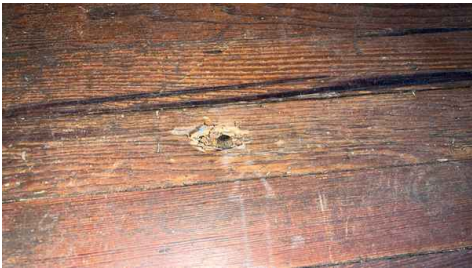
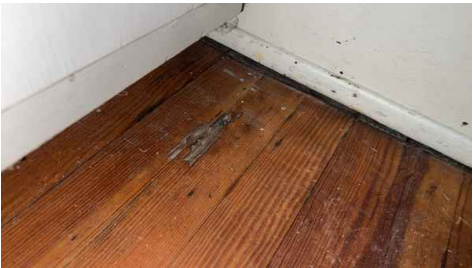
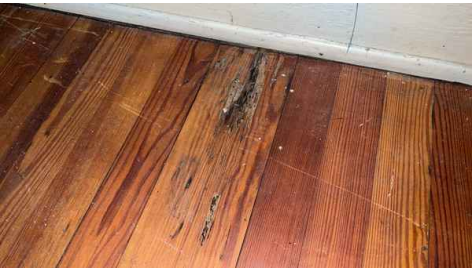
Potential pest damage was observed on the flooring, which may affect the integrity of the materials if left unaddressed. I recommend having a licensed pest control specialist evaluate the area to confirm the presence and extent of any infestation. If damage is confirmed, further evaluation and repairs by a qualified contractor may be necessary to restore the affected flooring.

Recommendation  
Contact a qualified professional.

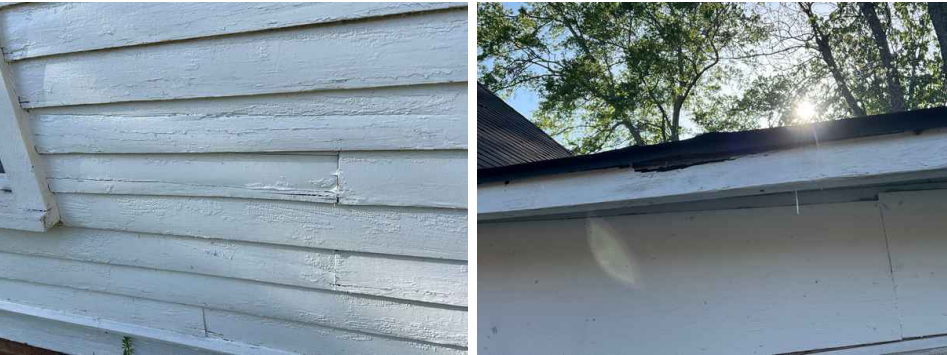
14.1.1 Wall-Covering, Flashing & Trim

DAMAGED WALL-COVERING MATERIAL

Damage was observed at the exterior wall-covering material, which may lead to moisture intrusion or further deterioration if not addressed. I recommend having a qualified professional evaluate the extent of the damage and perform any necessary corrections to maintain the integrity and weather resistance of the exterior.

Recommendation  
Contact a qualified professional.

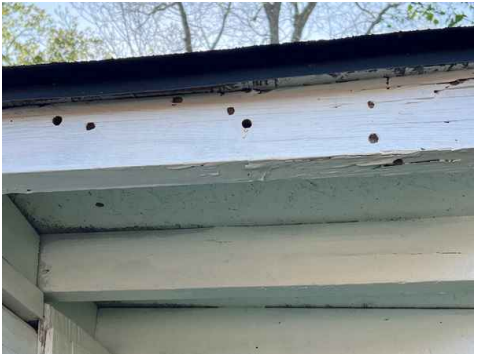
14.1.2 Wall-Covering, Flashing & Trim

Pest damage was observed at the exterior of the home, which may compromise the integrity of building materials and lead to further issues if not addressed. I recommend having a licensed pest control specialist evaluate the extent of the damage and perform necessary treatment. Additionally, a qualified contractor should assess and repair any affected areas to restore and protect the structure.

Recommendation  
Contact a qualified pest control specialist.

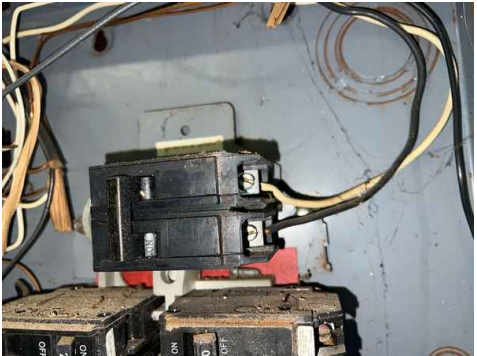
14.3.1 Electric in the Garage

During the inspection, I found a concerning issue with the electrical system. It appears that a large-sized breaker is connected to small-gauge wire, which can create a hazard. This is known as an ampacity problem. It's important that this issue is addressed promptly by a licensed electrician to ensure that the electrical system is operating safely and efficiently.

Recommendation  
Contact a qualified electrician

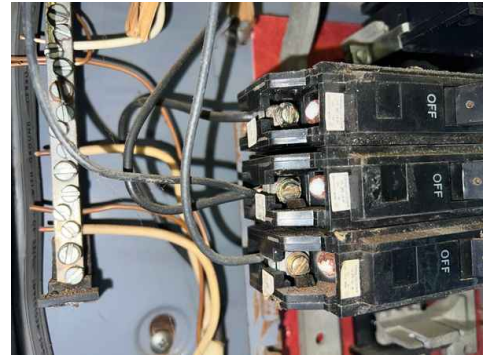
## 14.3.2 Electric in the Garage

**DOUBLED HOT CONDUCTORS**

During my inspection, I observed doubled hot conductor wires connected to the same breaker disconnect. It's important to ensure that each breaker has just one conductor wire connected to it to prevent any risk of loose connections, overheating, arcing, and potential electrical fires. Recommend further evaluation of the electrical system by a licensed electrician to ensure that all wiring is correctly and safely installed.

Contact a qualified electrician

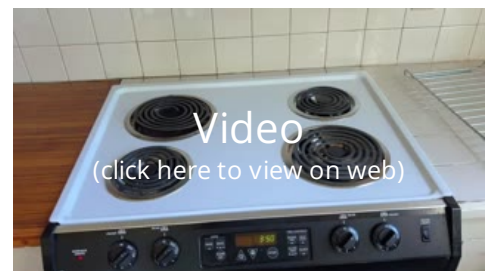
##### **BURNER NOT LIGHTING**

I observed that one or more heating elements did not turn on when operated.

Contact a qualified appliance repair professional.

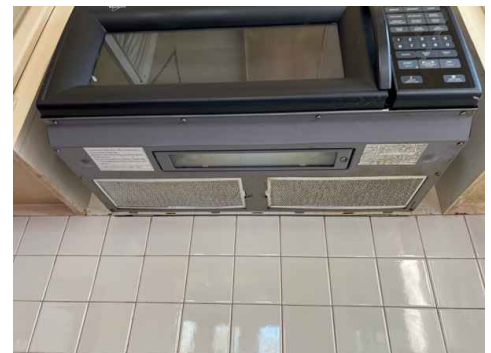
#### 15.4.1 Built-in Microwave

##### **LIGHT DID NOT TURN ON**

During the home inspection, I observed that the light under the microwave was not functioning. This issue may be due to a burnt-out bulb, a faulty light socket, or a problem with the control board. Further evaluation and repair by a qualified technician are recommended to determine the exact cause and resolve the issue.

Contact a qualified appliance repair professional.

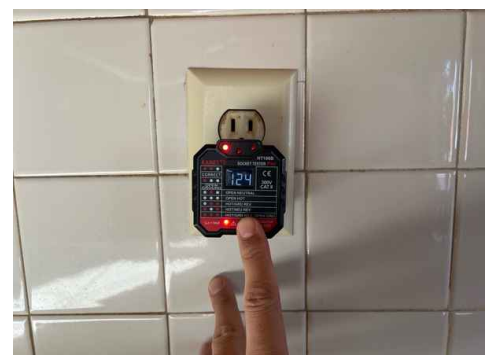
#### 15.6.1 GFCI & Electrical in Kitchen

##### **NOT GFCI PROTECTED**

It was observed that no GFCI outlet was present in the kitchen. To ensure safety, it is recommended that a licensed electrician install a GFCI outlet in the kitchen. This will provide protection against electrical shock and reduce the risk of electrical hazards.

Contact a qualified electrician
